CANDELARIA HALL

University of Northern Colorado

GREELEY, CO | PROGRAM PLAN | APRIL 2023

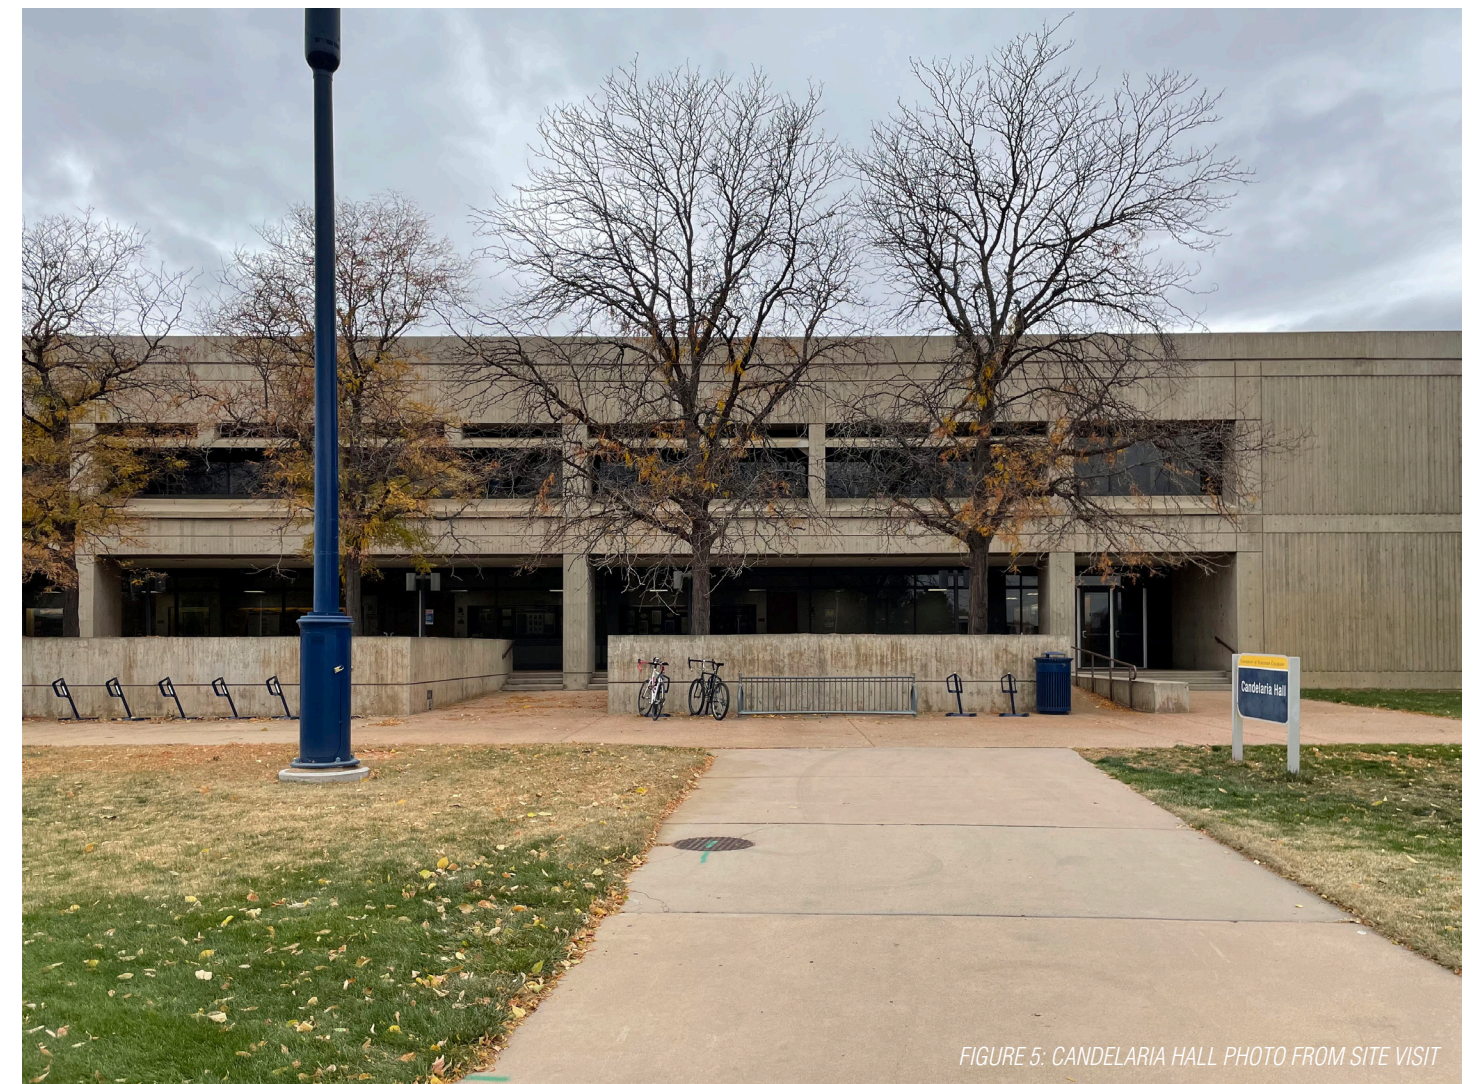
FIGURE 5: CANDELARIA HALL PHOTO FROM SITE VISIT

The exterior of Candelaria Hall consists of a cast in place concrete facade with deep recessed windows and concrete solar shades on the east and west sides. The exterior is generally in good shape, with the exception of the concrete solar shades, which show cracking and signs of deterioration.

Remove the existing concrete sun shades, and replace them with a light weight metal sun screen. These screens could be conceived as a form that spans two bays vertically to break down the overall scale of the elevation. The windows would also be replaced, which presents an opportunity to establish a relationship between these new sun shades and the window mullion pattern.

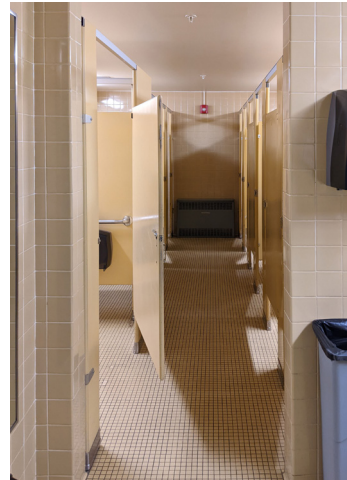
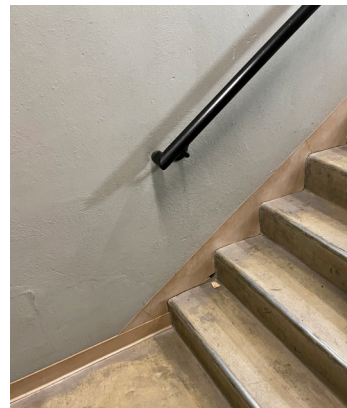
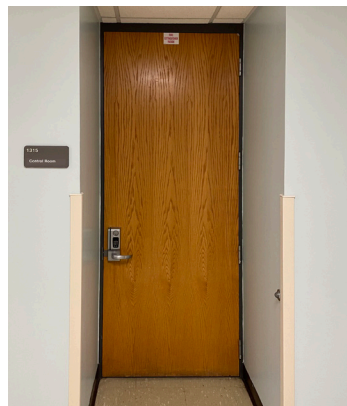
FIGURES 12, 13, 14: CANDELARIA HALL
PHOTO FROM SITE VISIT

Other code-related issues Candelaria faces are related to ADA accessibility needs. The deficiencies found are as follows:

- Handrail Extensions
- Guardrail Heights
- Signage (ADA)
- Room Entrances (ADA)
- Elevator Upgrades (ADA)
- Bathroom Clearances (ADA)
- ADA in Communal Space

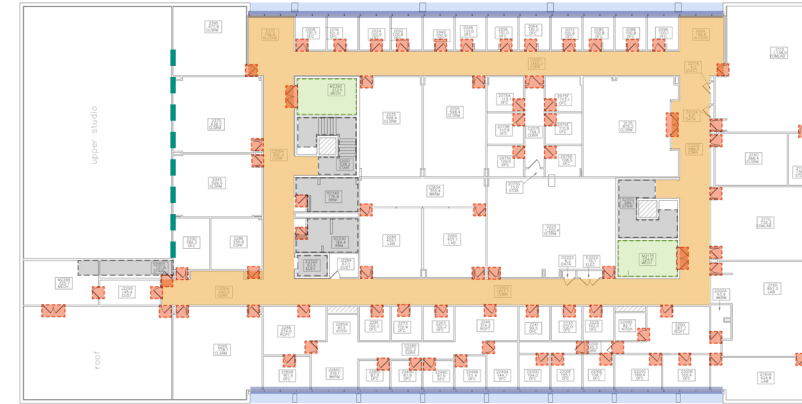
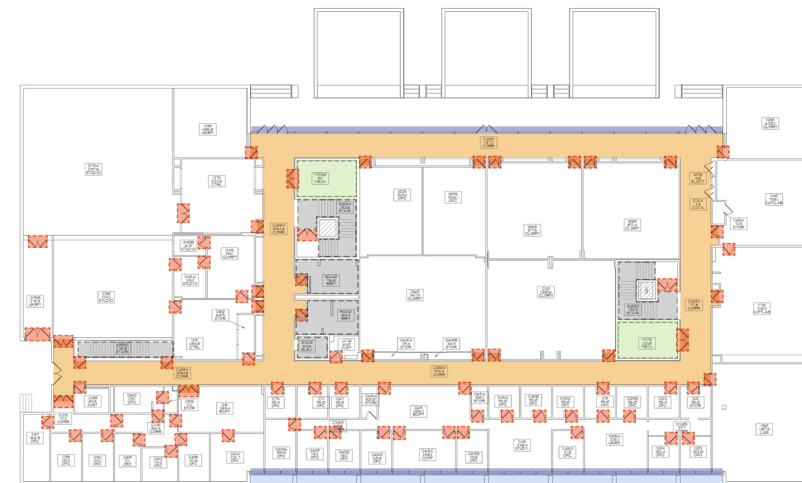
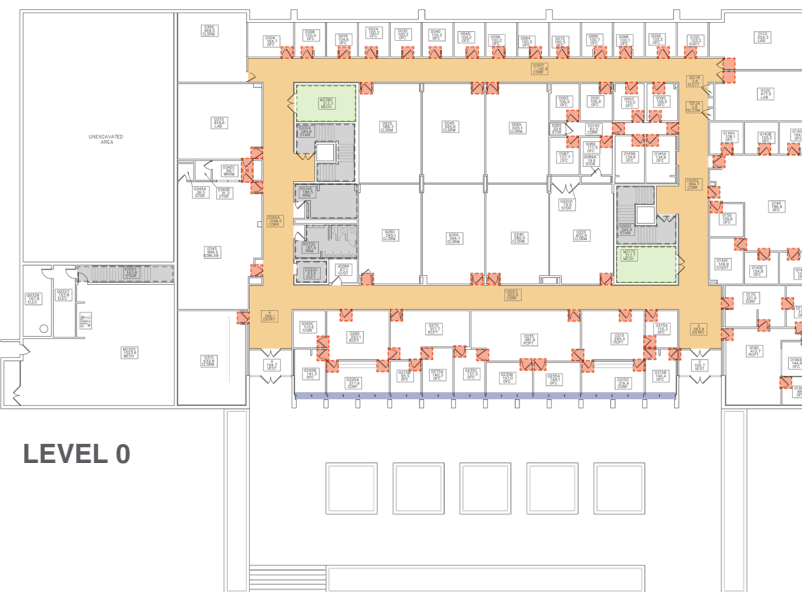
ARCHITECTURAL: Remove / Replace Sunshades
Replace Windows

FINISHES: Replace Ceiling
Replace Flooring with LVT
Replace Lighting
Replace Elevator Finishes

ADA UPGRADES: Accessible Restroom Stalls
Elevator Modifications + Relocation of Equipment Room
Replace Doors + Door Hardware
Guardrails + Handrails

STRUCTURAL: Structural Repair of Existing Crack in Exposed Concrete Structure

MECHANICAL: Remove / Replace Air Handlers and Outside Air Dampers
Remove / Replace Heat Exchanger
Convert Heating and Chilled Water Systems to Variable Flow

ELECTRICAL: Remove / Replace Primary Transformer
Remove / Replace Main Switch Gear
Remove / Replace Motor Control Center w/ new Panel
Emergency Power Upgrade

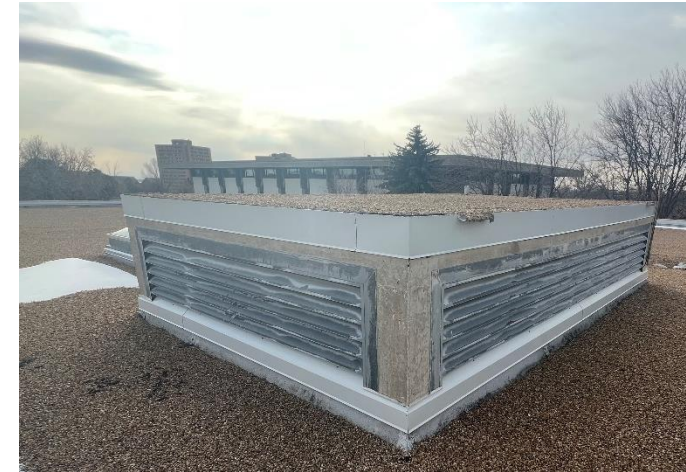
Outside Air Louvers

The outside air louvers located on the roof are weathered and appear to be from the original installation.

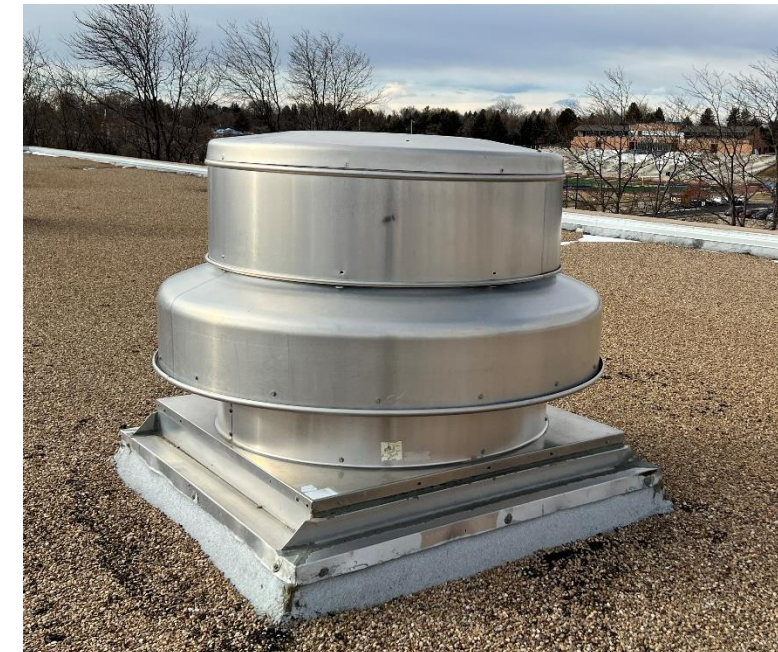
EF-1 Located On Roof

The general building exhaust is served by four centrifugal fans EF-1, EF-3, EF-4, and EF-5 which are located on the roof. These fans were replaced in 2005 and are still within their expected life spans of 25 years as defined by ASHRAE. The sidewall propeller fans EF-2 and EF-6 provides exhaust for the mechanical room and switch gear room respectively.

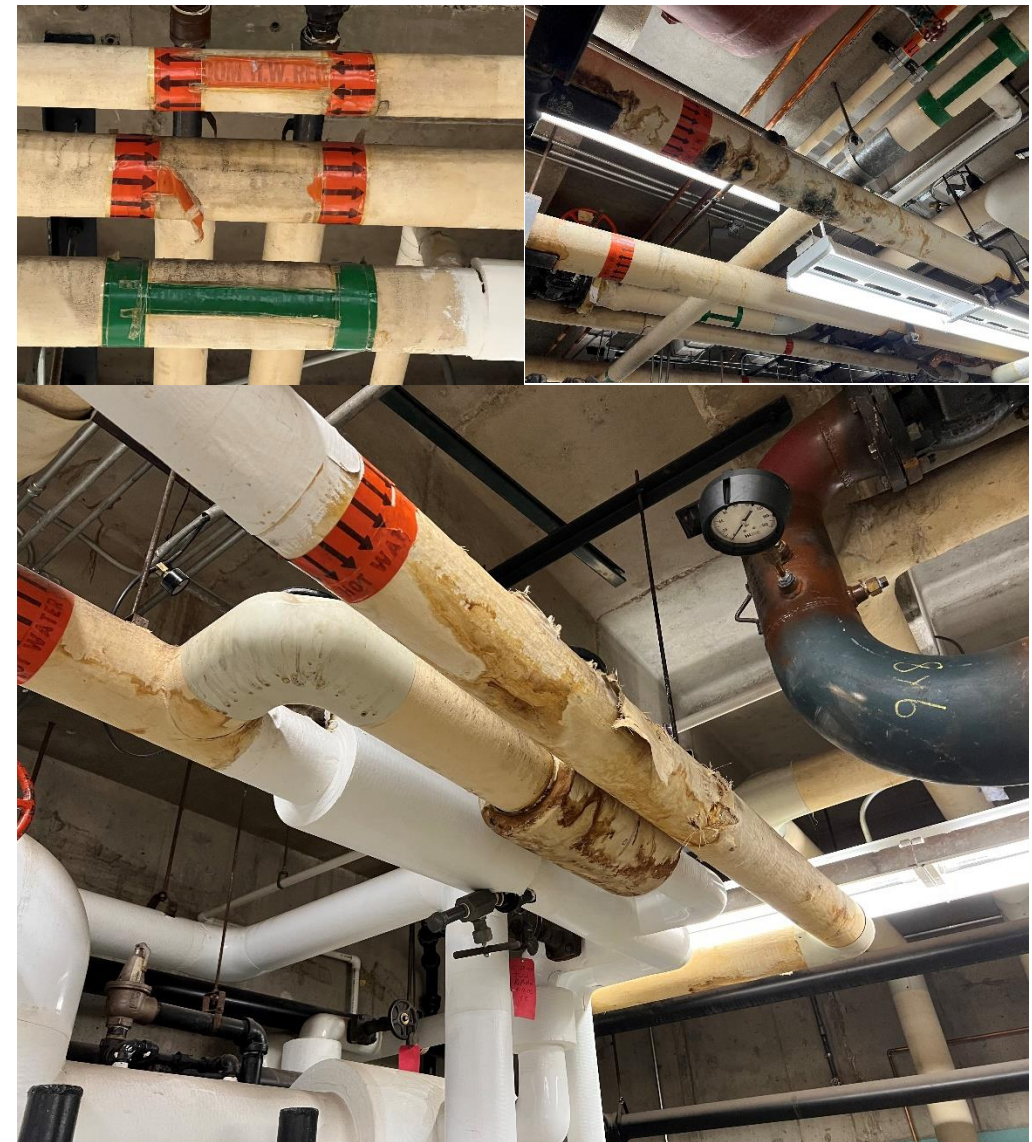
Much of the pipe insulation and pipe tags within the mechanical room are damaged and in need of replacement. Additionally, there are several lengths of pipe that do not have any insulation.
