MCKEE HALL

University of Northern Colorado

GREELEY, CO | PROGRAM PLAN | APRIL 2023

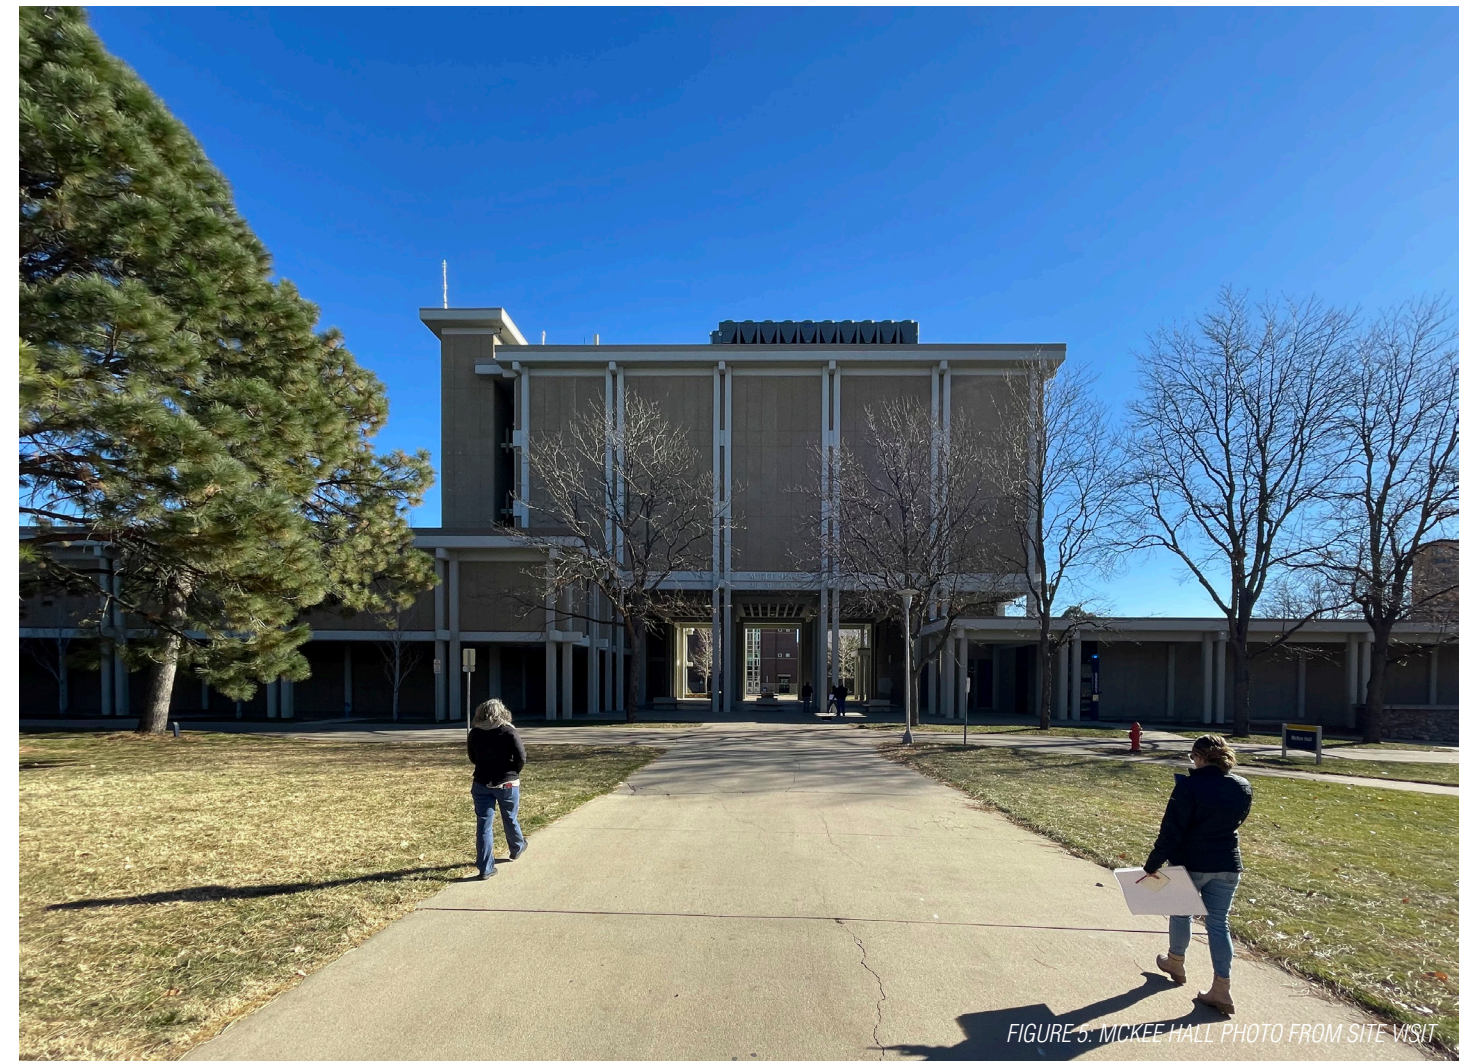
FIGURE 5: MCKEE HALL PHOTO FROM SITE VISIT

The exterior of McKee Hall consists of a cast in place concrete structure painted white with tan exposed aggregate precast infill panels. The exterior finishes are durable and as such are generally in good condition.

However, the concrete envelope is generally low performing from an energy standpoint. Exterior walls are concrete exterior with interior metal studs and batt insulation and drywall on the inside face. Because of the thermal bridging at the studs, the effective R value of the exterior wall assembly is likely approximately R7.4. Windows are generally single pane, likely in the R-1 to R-2 range for thermal performance. In addition, the building entries do not incorporate a vestibule.

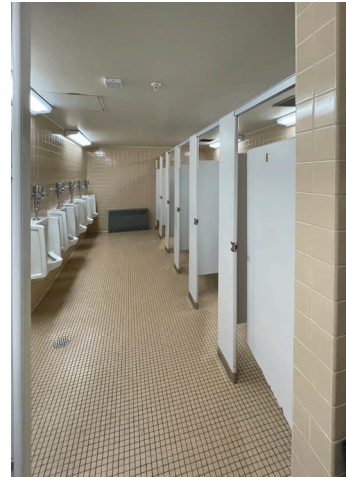
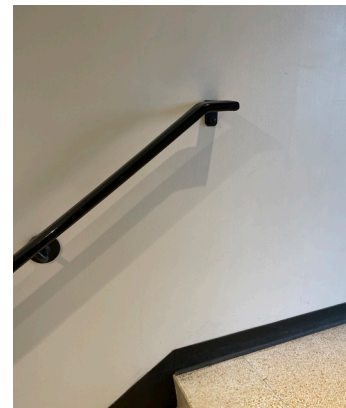
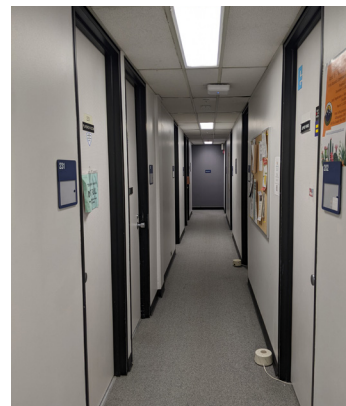
FIGURES 10, 11, 12: MCKEE HALL PHOTO FROM SITE VISIT

- Handrail Extensions
- Guardrail Heights
- Signage (ADA)
- Room Entrances (ADA)
- Elevator Upgrades (ADA)
- Bathroom Clearances (ADA)
- ADA in Communal Space

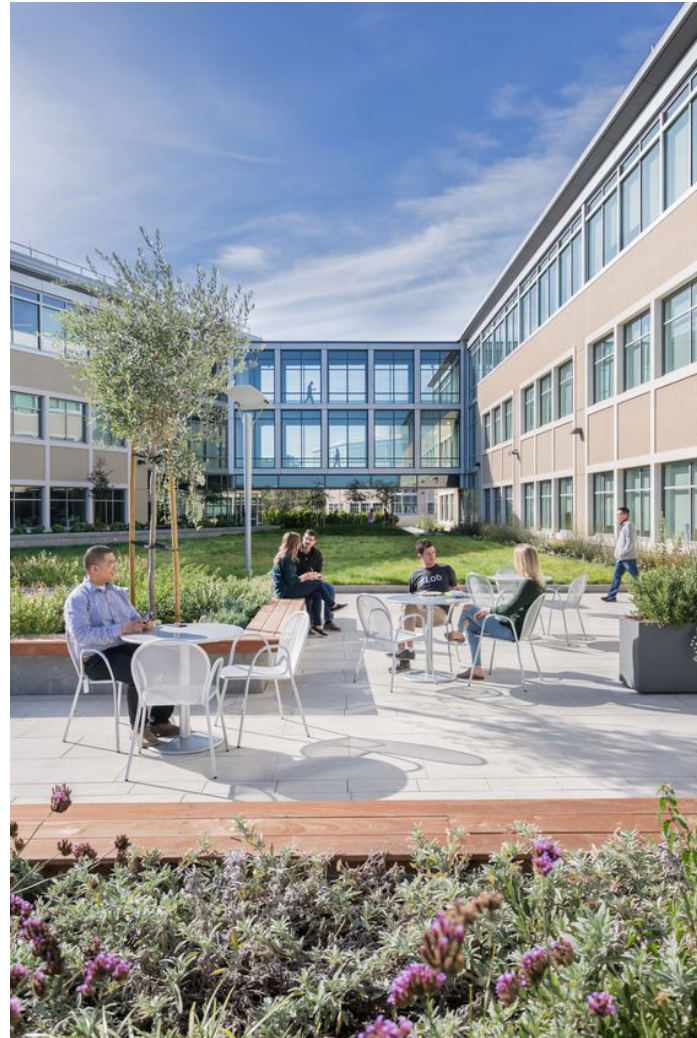
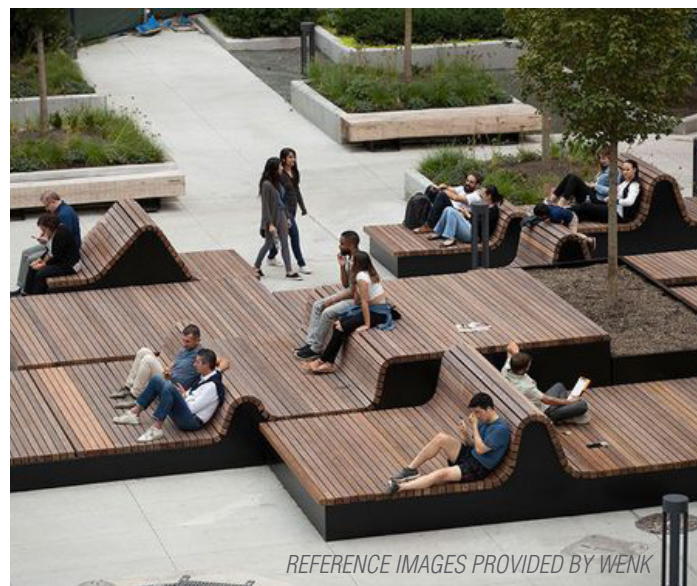
REFERENCE IMAGES PROVIDED BY WENK

There are several items that could be added to enhance the exterior spaces and increase usability by students and faculty. Update the breezeway to create useable space, and upgrade the amphitheater to provide comfortable seating areas to study and gather.

Planters, seatwalls, additional material types, and varied seating options will improve circulation and create a high quality space.

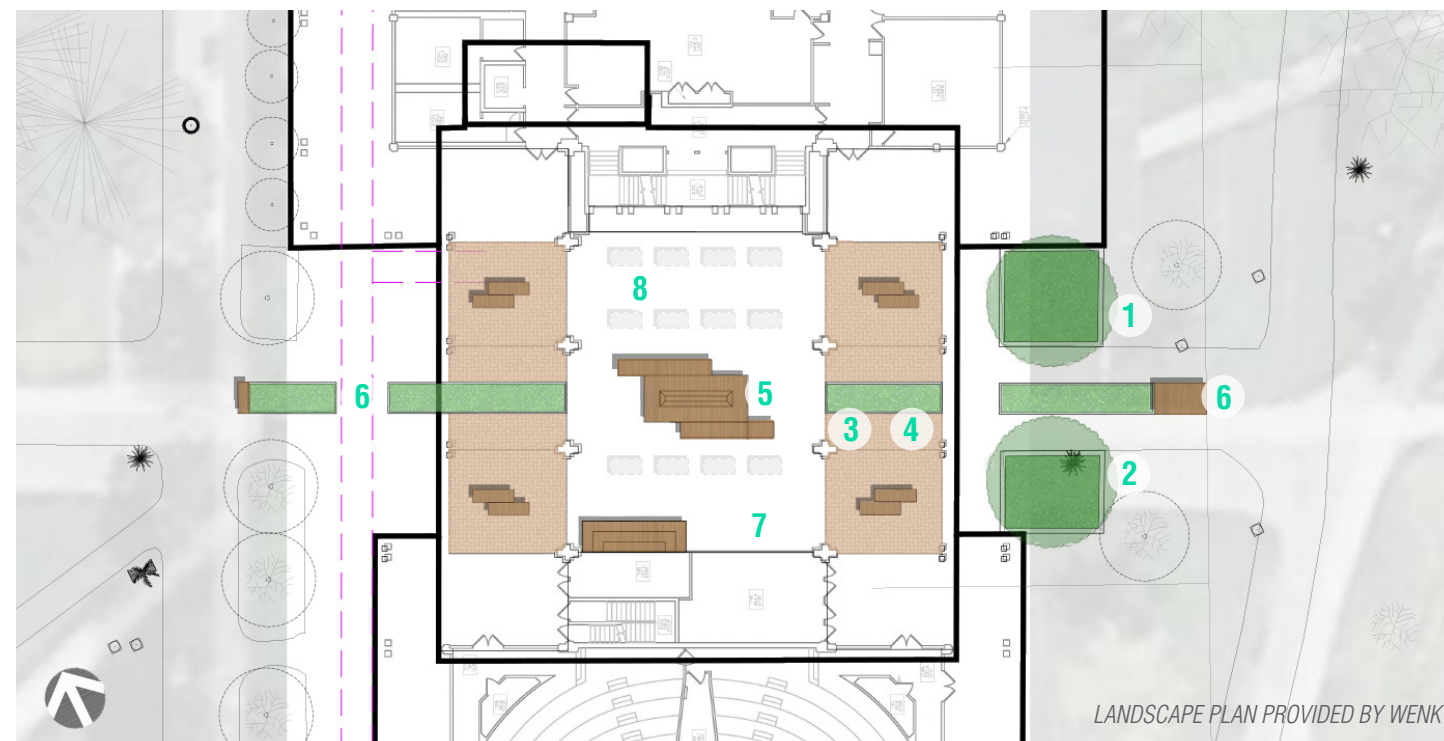
- 3 Remove the concrete planter boxes with seats attached.
- 4 Remove concrete paving at the locations of the existing planter and replace with concrete unit pavers to help break up the ground plane.
- 5 Add large furnishings into the space for student gathering and interaction. These could be a variety of sizes and configurations but would still keep spaces open for events or student group set up.
- 6 Use the furnishings and raised planters as barriers for vehicles.
- 7 Maintain open wall for student chalk board.
- 8 Temporary student table set up space (6'x3' tables).

- 1 Expand the area at the top of the amphitheater and reroute the sidewalk to provide a greater separation between pedestrians and the amphitheater. Add seating for student use.
- 2 Replace the concrete at the bottom of the amphitheater to create a seamless ADA ramp into the building and improve drainage by replacing inlets.
- 3 Replace a portion of the amphitheater with terrace seating, 12" height x 24" wide.
- 4 Maintain stair access along the edges of the building and include code compliant handrails.

- 5 Create a larger gathering space within the lawn with seating around the edges and a clear path to it from the building and amphitheater.
- 6 Provide a separation from the edge of the amphitheater and create a plaza edge.
- 7 Add (4) trees and understory planting.

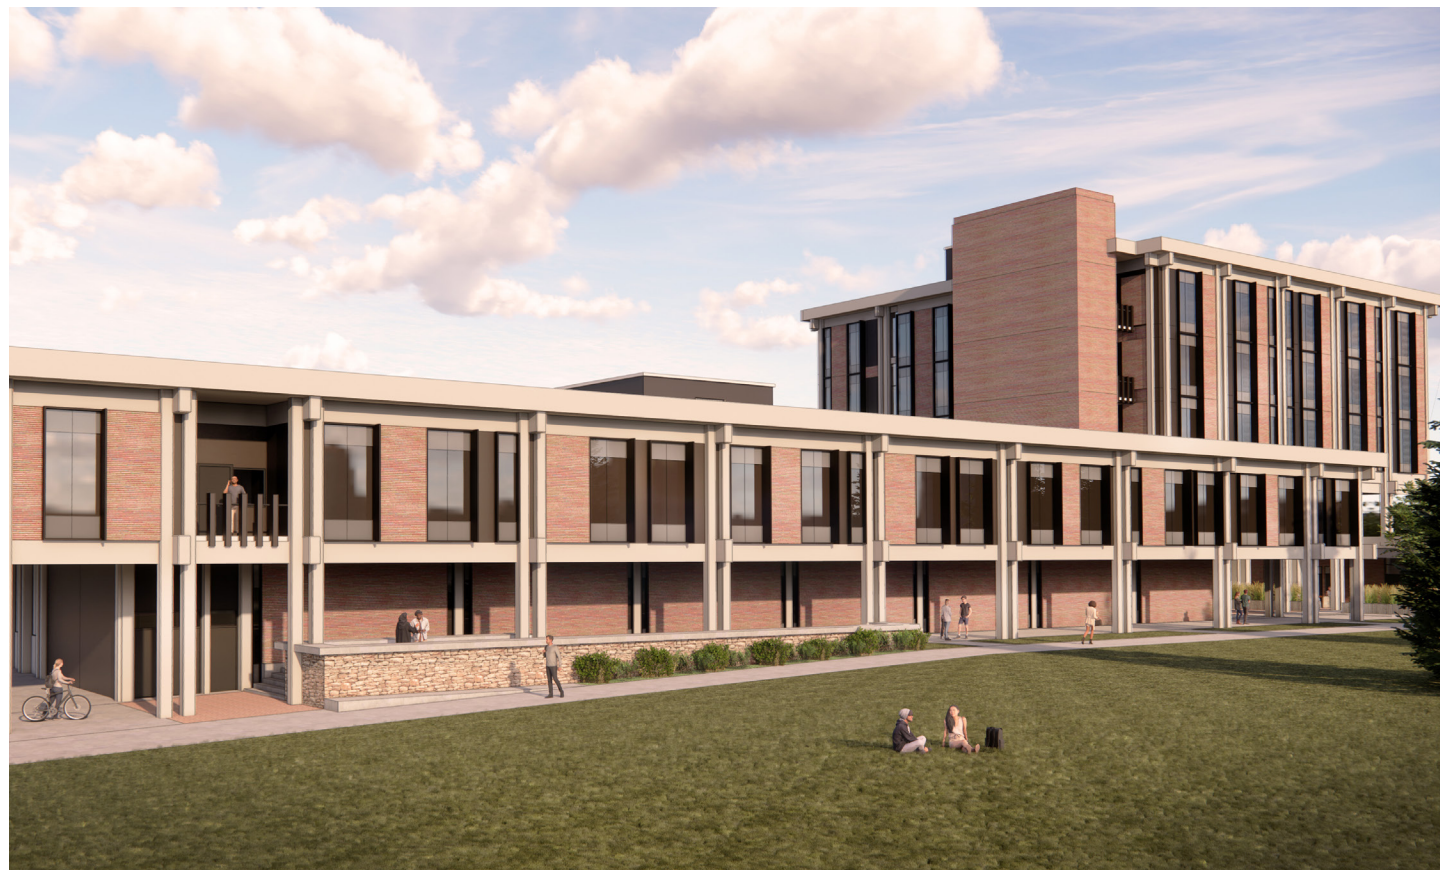
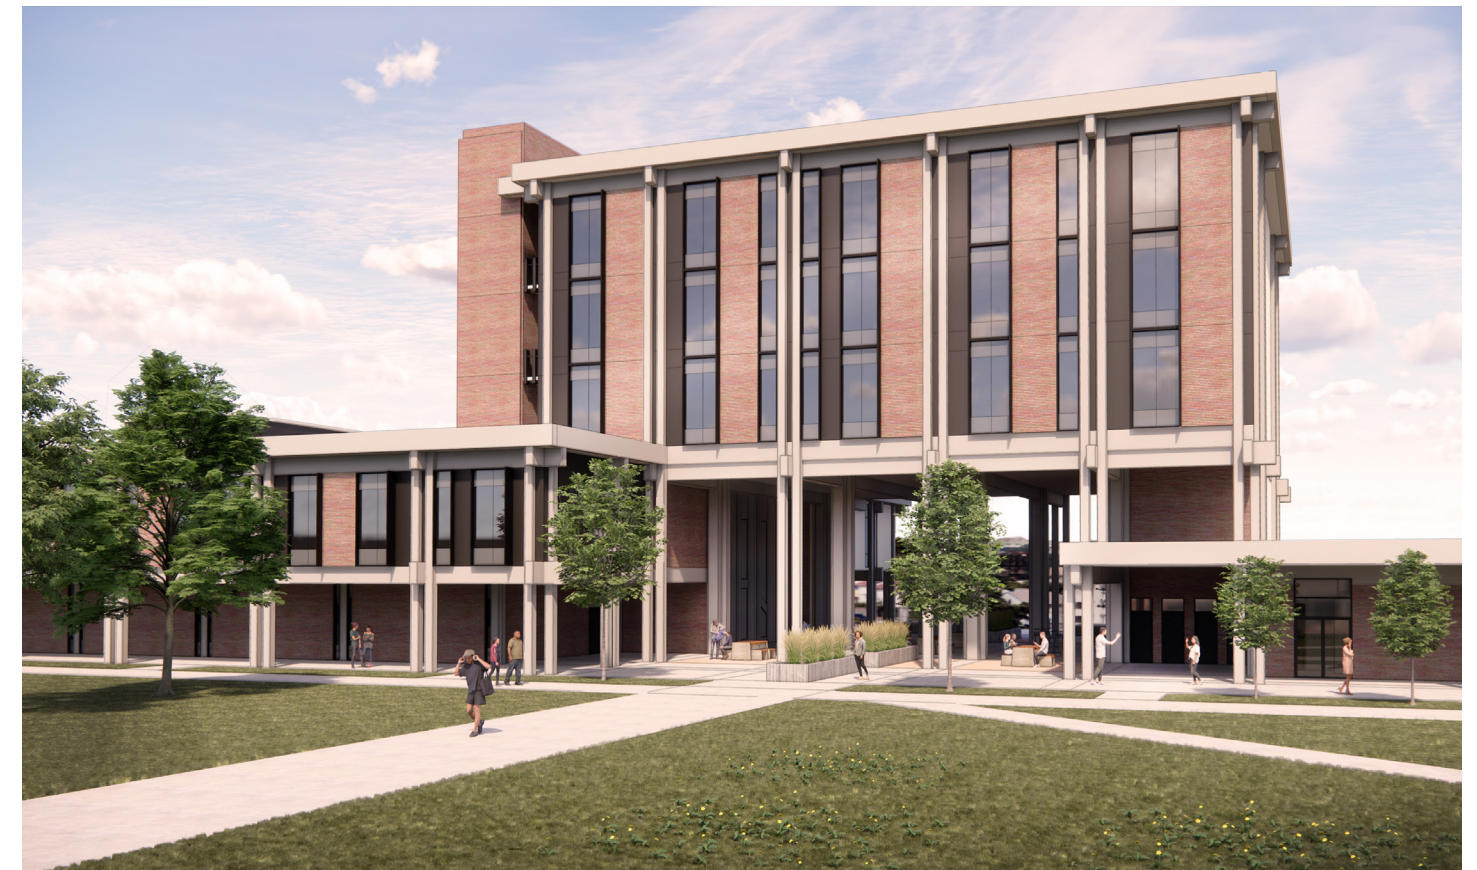
Structurally, the precast infill panels can be removed in part or in their entirety. These could be replaced with higher performing insulated panels with windows. While this would vastly improve the experience for building occupants, it would also allow more articulation to the exterior façade, creating a more inviting aesthetic.

Add vestibules to main entrances of classroom building. This will improve the thermal efficiency and comfort, and act as wayfinding elements as the building is used by the public and currently has no signage or directionality.

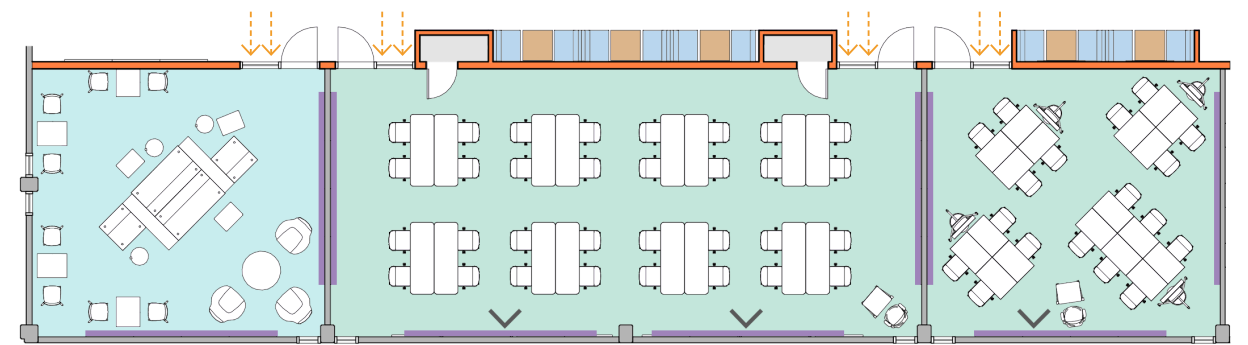
LEVEL 1 ENLARGED CLASSROOM PLAN

- Updated Classroom:
 - New Carpet Tile
 - New Paint
 - New Acoustical Ceiling Tile
 - New Indirect Lighting
 - New Classroom Entry Door / Hardware
 - A/V and Technology Upgrades
- Updated Student Space:
 - New Carpet Tile / VCT
 - New Paint
 - New Acoustical Ceiling Tile
 - New Indirect Lighting
 - New Entry Door / Hardware
 - A/V and Technology Upgrades
- ADA Entrance
 - Sidelight
 - New ADA Hardware
 - Accessible Signage
- Modified Storage:
 - Adjustable Shelving
- White Board
- Corridor Study Booths
- Teaching Wall

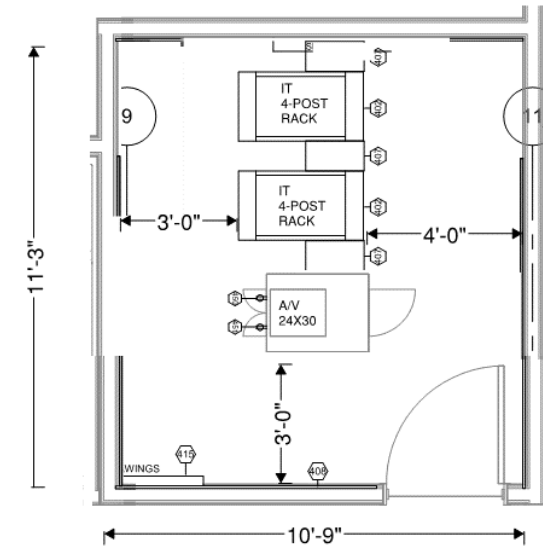
A generic example of a TR is shown below. The size of IT rooms and the quantity of equipment racks should be detailed during the design phase.

The following are recommended guidelines for the TR Rooms

FUNCTION	<ul style="list-style-type: none"> • Houses local distribution cabling terminations and technology equipment.
LOCATION	<ul style="list-style-type: none"> • Located so that horizontal cable runs are less than 295 ft (90 m). • Located directly off of a service corridor or hallway to provide access to maintenance and operational personnel. • Two per floor • Stacked
SIZE	<ul style="list-style-type: none"> • Minimum 10' X 10'
ADJACENCIES	<ul style="list-style-type: none"> • Cable distance from the room to the furthest serving point is 295 ft (90 m).
FLOOR	<ul style="list-style-type: none"> • Floor shall have VCT tiles of a type that does not promote static or static dissipative tile. • Structural floor should support a minimum of 50 lb/sq. ft.
CEILING	<ul style="list-style-type: none"> • Ceiling shall be treated with a spray on sealant to prevent flaking of spray on fire proofing of the slab above. There shall be no drop ceiling in this space.
