VIRTUAL FIRELD TRIPS – 1860's FARM

McBroom Cabin

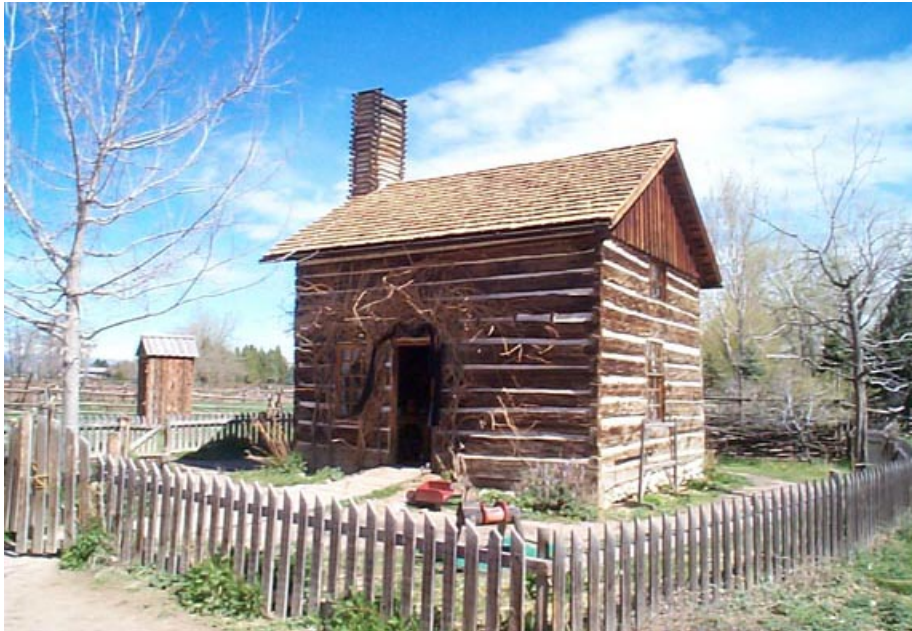
The log cabin is an original, built by the McBroom family. Two McBroom brothers homesteaded in the South Platte River valley in the early 1860s. We think that this cabin is the oldest remaining log building in the South Platte and Littleton region. After the Littleton Historical Museum got the cabin, it began to restore the building to accurately reflect how a family would have lived in a log house during the 1860s.

McBroom cabin

Restoring the cabin to near its 1860s condition was a big job. Many things had to be replaced, including doors, windows, floors, the stairs, and the chimney. The cabin was both chinked and caulked. Chinking is placing pieces of wood between the logs. Caulking is a mixture of lime, sand, straw (or hair) and water which seals the gaps between the logs. As the seasons change, the logs expand and contract. Replacing the caulking was (and is) a never-ending job.

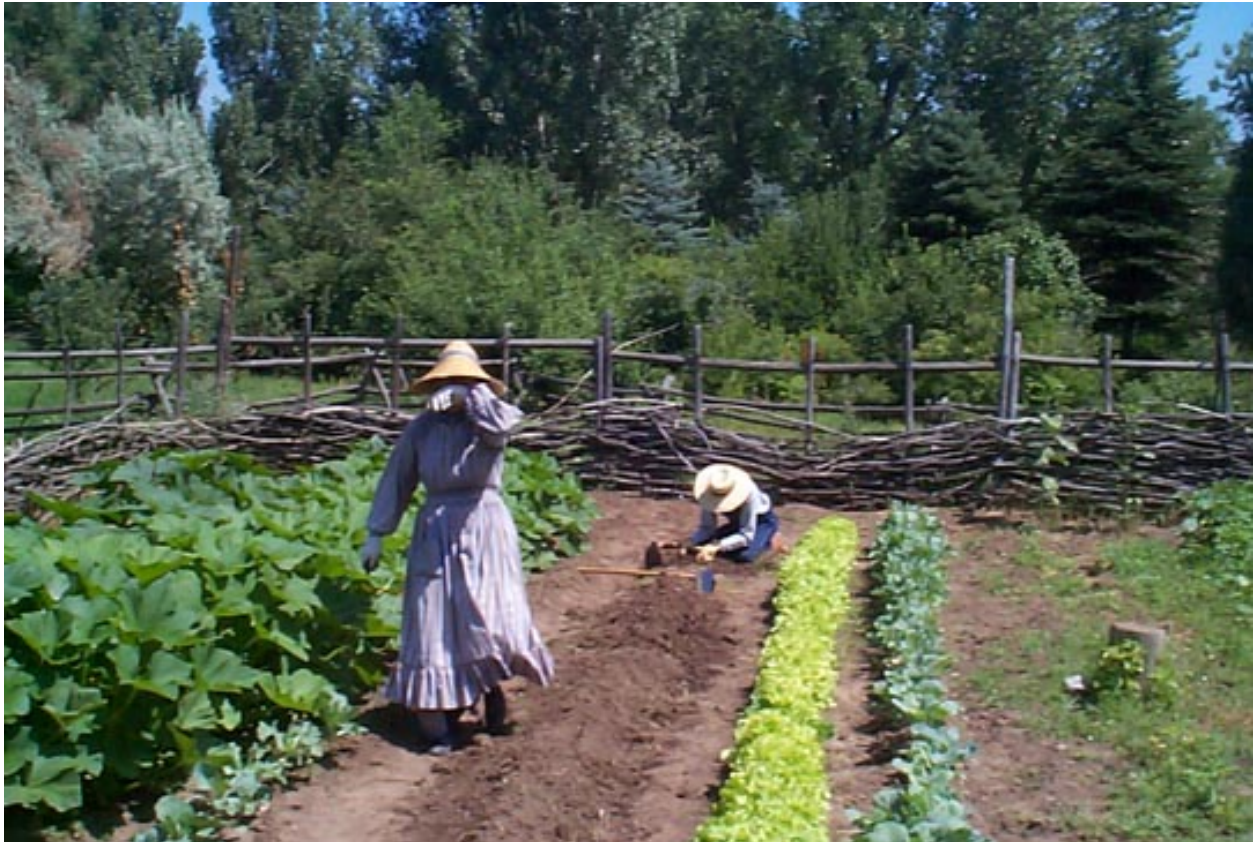
Garden in Littleton

The vegetable garden was enclosed by a wattle or thatched fence. A wattle fence is a series of poles, tree saplings, and brush which are woven together. The tightly woven material kept chicken and other small animals out of the vegetable garden.

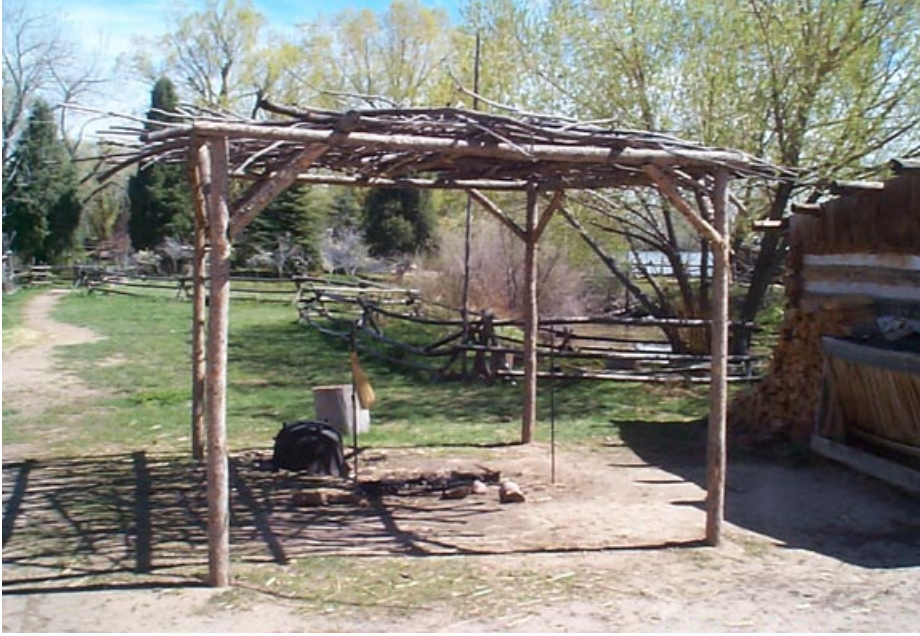
A summer kitchen

A very simple wooden shelter was built for this area. It has four open sides and a roof made of tree saplings. It was a little more than a way to get out of the sun. In the summer time, the sun is hot and severe in Colorado. The sun also shines often in the winter months, but an open fire feels warm and pleasant in the winter. Doing the laundry outdoors in the winter, however, was probably not all that pleasant!

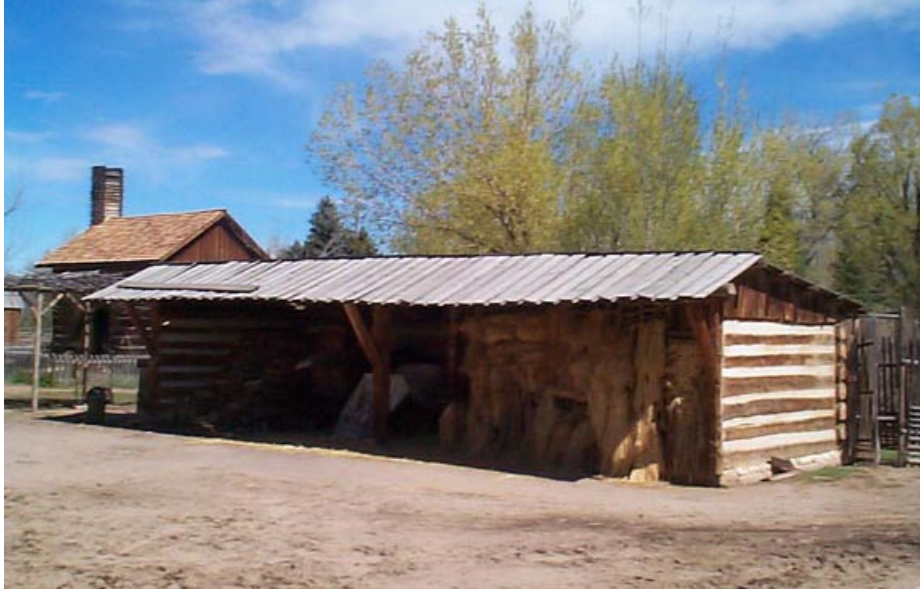
The lean-to is a log building in which is stored equipment, wood, and other goods. Part of it also serves as a chicken coop. The front of the building faces south and is open all across the side. It was purposely set this way so that in cold winter months the sun will shine into the lean-to. Quite often in winter the chickens are stretched out in front of the coop. It almost looks like they are sunbathing!

Lean-to

The inside of the chicken coop was made from lodgepole pine mixed with saplings that had been cut to clear the land. The saplings were nailed onto the lodgepole pine. The front of the building was covered with bundles of thatch (straw tied together and lashed to the front of it). During each season there is much repair work to do on the thatch bundles. Inside the coop are tree limbs set up off the ground. Chickens jump up on these to roost.

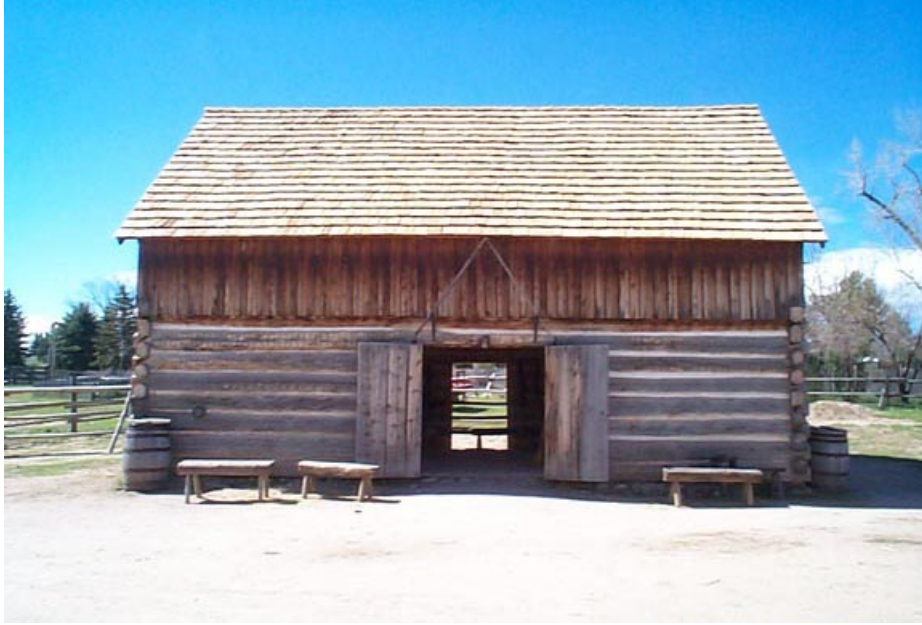
The barn is often the focal point of a farm. That is so whether the barn was built in the 1860s or the 1980s. It was (and is) very important because the barn shelters some of the livestock, feed, tools, and sometime even the farm family. This barn was a reconstruction of a hand-hewn barn. It was built in the summer of 1985. But it was built according to the materials and knowledge of the 1960s.

A barn

The barn was built of lodgepole pine. Lodgepole pine was ideal because these logs do not taper as much from bottom to top as ponderosa pine logs do. Each log was flattened on the sides. They were also peeled of their bark. The builders also used such tools as axe and adz to cut notches at the ends of the logs. Logs were used in the bottom of the barn and then sawn lumber was used on the top. The hinges for the doors and windows were made by local blacksmiths.

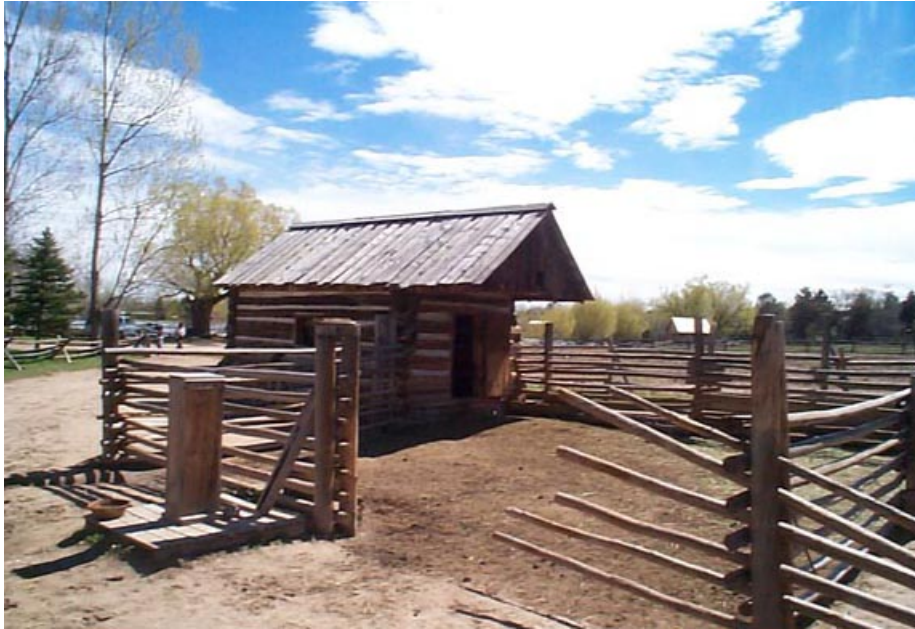
The sheep shelter was actually a home used by a family for a time. It was their first house and they lived in it a year or two. After the family moved into a larger structure, the shelter became an animal shelter. A number of families in this region followed the same pattern by starting in a small log dwelling. This specific has an overhang above the front door. We don't know exactly how it was used, but it may have been used as a front porch when the family lived in this shed. Anyway, such overhanging roofs were common on similar buildings in the Platte River valley at the time.

Sheep shelter

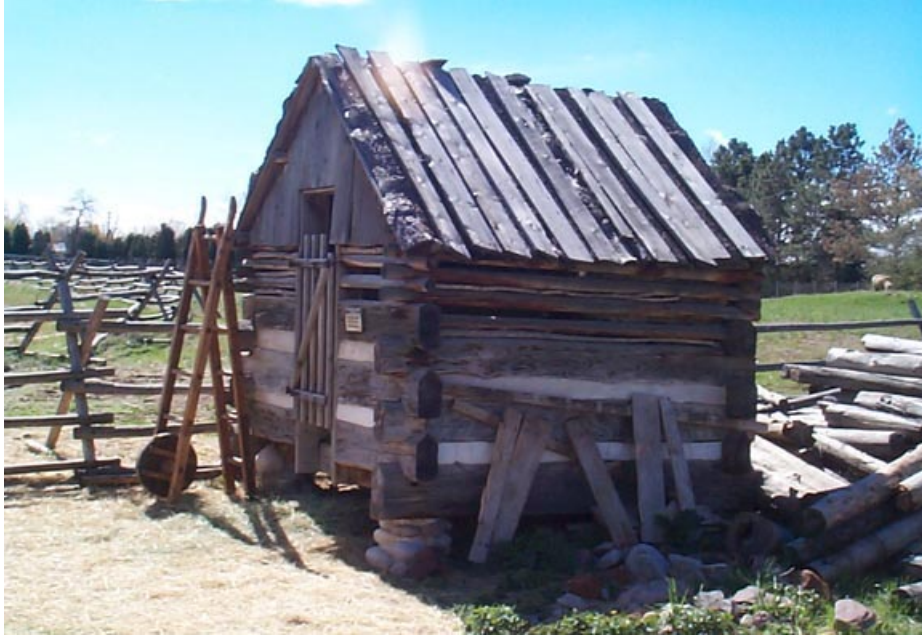
The corn crib was built up off the ground. It sits on stone columns which then support large hand-hewn logs. This method of building corn cribs allowed air to flow under the building. There was also no chinking or caulking between the logs that made up the walls. This allowed air to flow through the crib and keep the corn inside dry. Drying helped preserve the corn for later use.

Corn crib

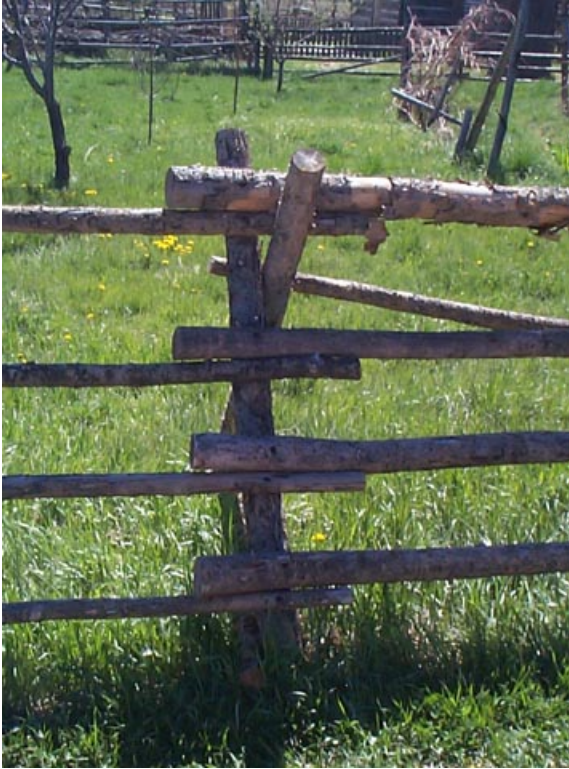
The fencing style you see at the left is called a jack-leg fence. The part of the fence that carries the long horizontal poles was built on the ground as a "X". The long poles were then nailed to the "X" with nails. These were probably cut nails from a factory in Massachusetts.

Fences and fields

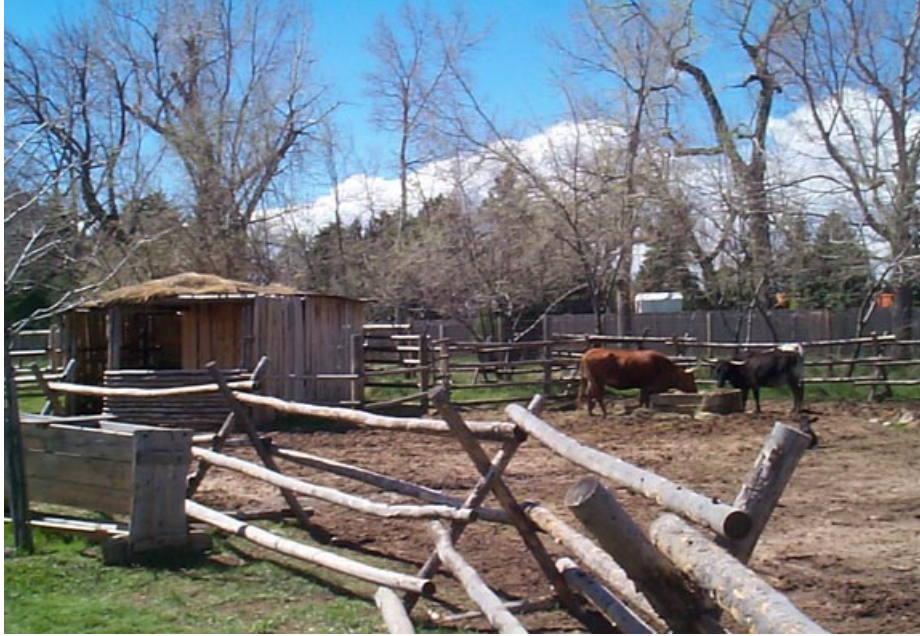
The oxen shelter is made of a system of poles that are nailed together. The poles are either lodgepole pine or cottonwood sapling from along the Platte River. These poles were then covered with bundles of thatch. Thatch was made from the straw left after harvesting oats and wheat. The thatch covering protected the oxen from the winds coming west.

Oxen shelter

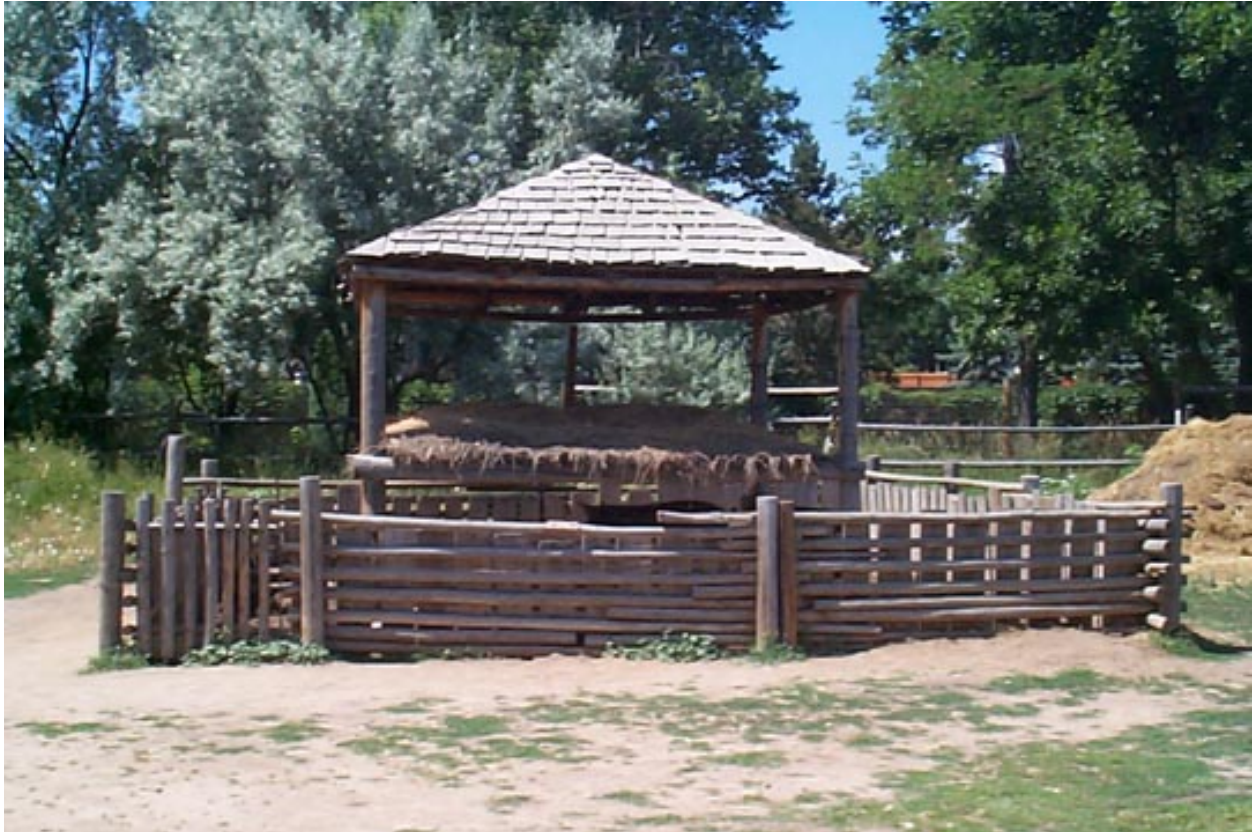
The pig sty is made up of several things. Inside the fence line is a run for the pigs, a feed trough, a water barrel, and an area in which the pigs just wallow around. There is also a shelter. The shelter has two purposes. Below are logs which the pigs can lay on. Above that is a storage rack that is for storing feed. One corner of the shelter faces the direction of the prevailing wind. With a little straw, the pigs can find protection from the cold winter winds.

Pig sty

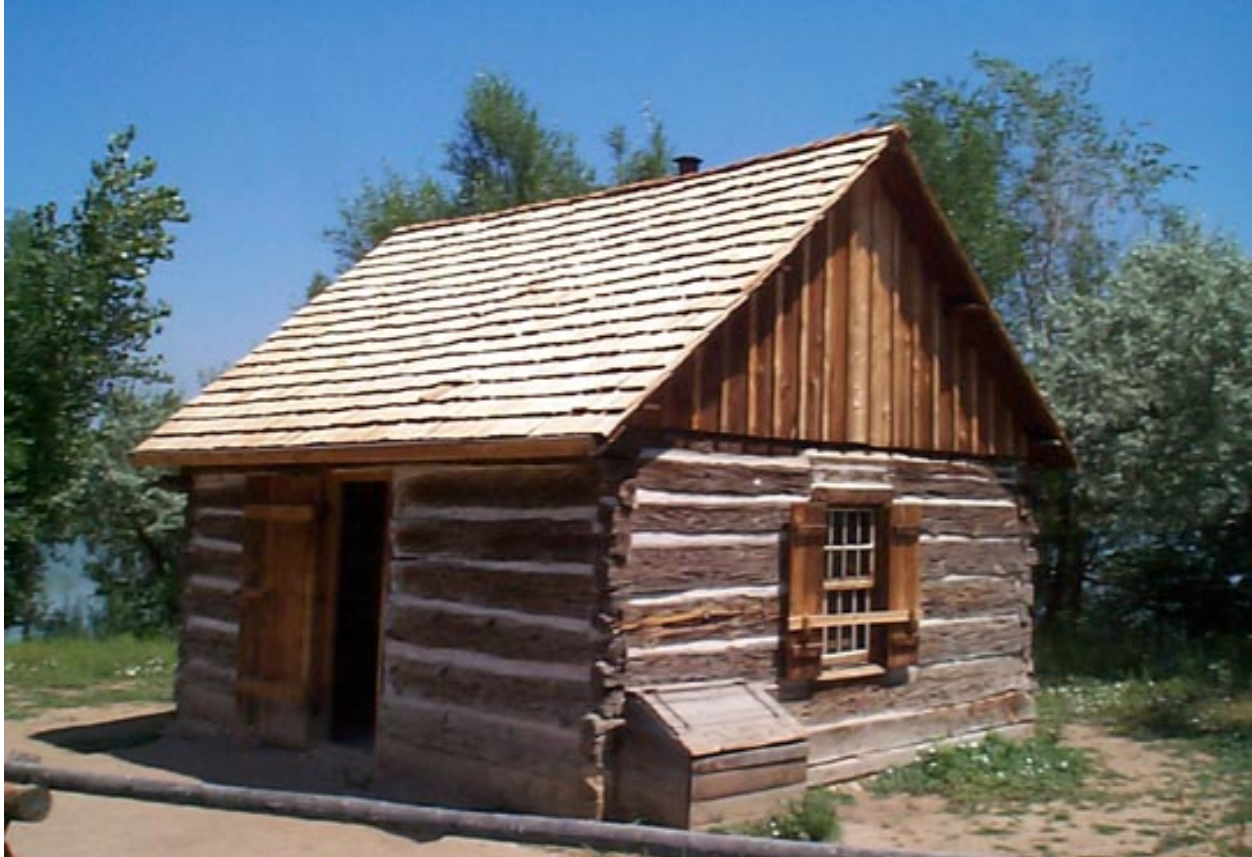
The log school house on the museum grounds is the first school built in Littleton. The building is used to represent the year 1868. That year was selected because that is the date on the box stove inside the school. The log building was built of either Ponderosa or lodgepole pine logs and was hand hewn. Most of the logs are original to the structure.

Schoolhouse in Littleton

The furnishings include the box stove, desks and benches, textbooks and writing materials for the students, and a desk for the teacher. The building was moved to the museum in 1972 and restored by the museum staff. The roof was replaced as were the windows and doors. People often question the use of shingles on the roof. In fact, shingles were available in Colorado territory in the 1860s. Some were made locally; others were freighted in overland from Missouri.
