VIRTUAL FIRELD TRIPS – 1890's FARM

Bemis House

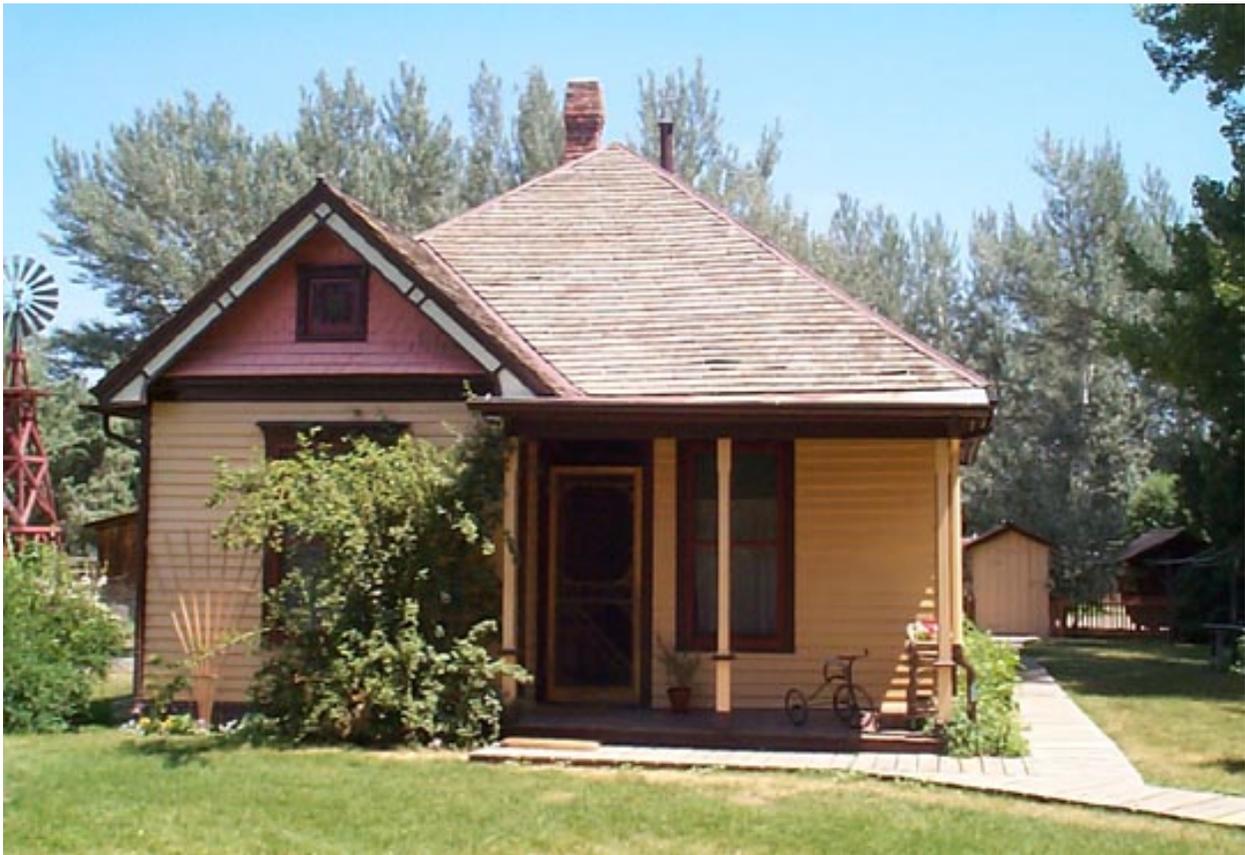
Bemis house

The Fred Bemis family built this house in 1889. It was originally located on Littleton Boulevard on the crest of a hill east of the railroad tracks. This house was selected to become a museum because is was a good example of common household size and of common architecture in the late 1890s. In addition, museum people kept track of information about the photo. They therefore know a good deal about the Bemis family. The house was moved to its present museum site in 1975.

Again, this house was selected to become a museum because it was representative of a small family farm house. Also, farming was important in Littleton at the time this house was built and Fred Bemis was involved in both farming and stock raising. The farm house was built using balloon frame construction. This became the dominant building method in the 20th century. When the house was originally built, it had no electricity, although electricity was eventually added to the house.

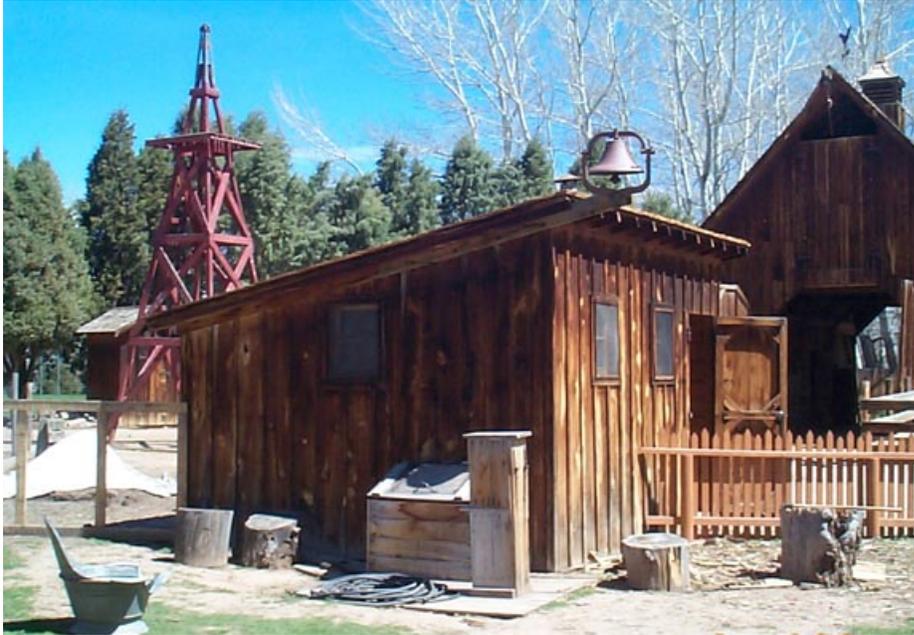
Tool shed

The tool shed is a reconstructed building. It was based on historical photos taken in the Littleton area. Many small farms had buildings that were used to house tools and supplies. A shed like this one would have been in addition to the farm's barn. This shed uses balloon frame construction, wood sheeting material for the walls and floors, and a shingled roof.

On the inside walls of the shed are many tools used for gardening, carpentry, and cleaning. The tools are laid out in a specific pattern. Most are hung on nails with an outline of the tools made in pencil. This makes it easier to put the tools away in their proper location. It also makes it easier to find them again. This was a common practice in the 1890s. Publications of the time show what was sometimes called a “fan pattern” in which tools were hung on nails or wooden pegs. Can you see any tools you recognize?

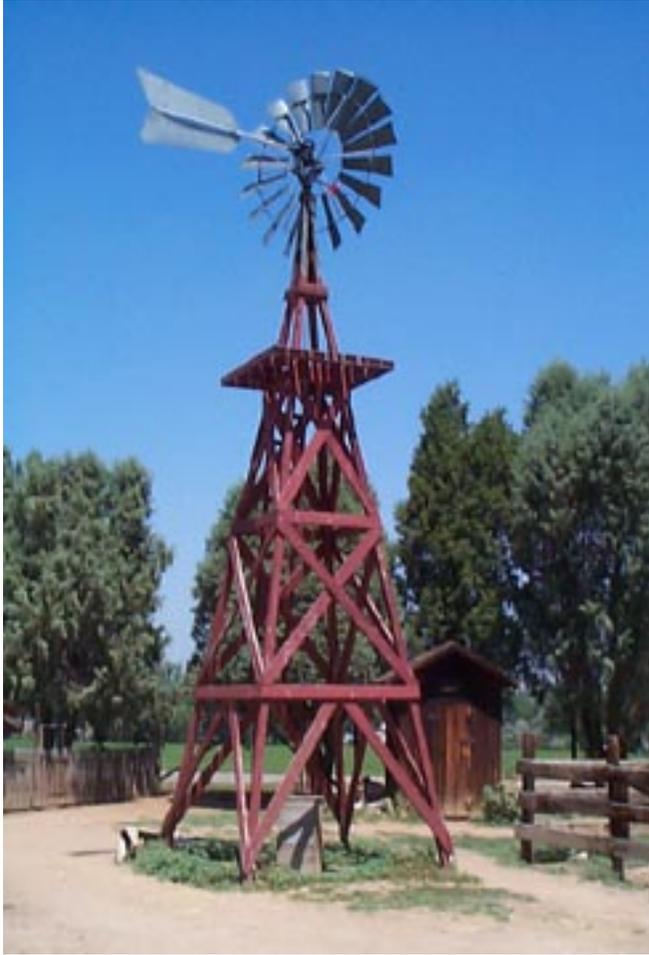
The Eclipse windmill on the farm is a restoration. The entire wood tower, the mill and mill tail were all part of that restoration. The mill mechanism, however, is an original. It was found in eastern Colorado 15 to 20 years ago. The windmill stands over a well. The well water is drinkable by humans although most of it is used for other purposes.

The pump at the left draws water from the well. The windmill cannot actually pump water now because the trees surrounding the farm get in the way of the wind. A windmill needs wind with a fairly high and constant speed to work well. That is why windmills worked well on the plains of eastern Colorado. Most of the water pumped from this well is used to water the farm's garden and livestock.

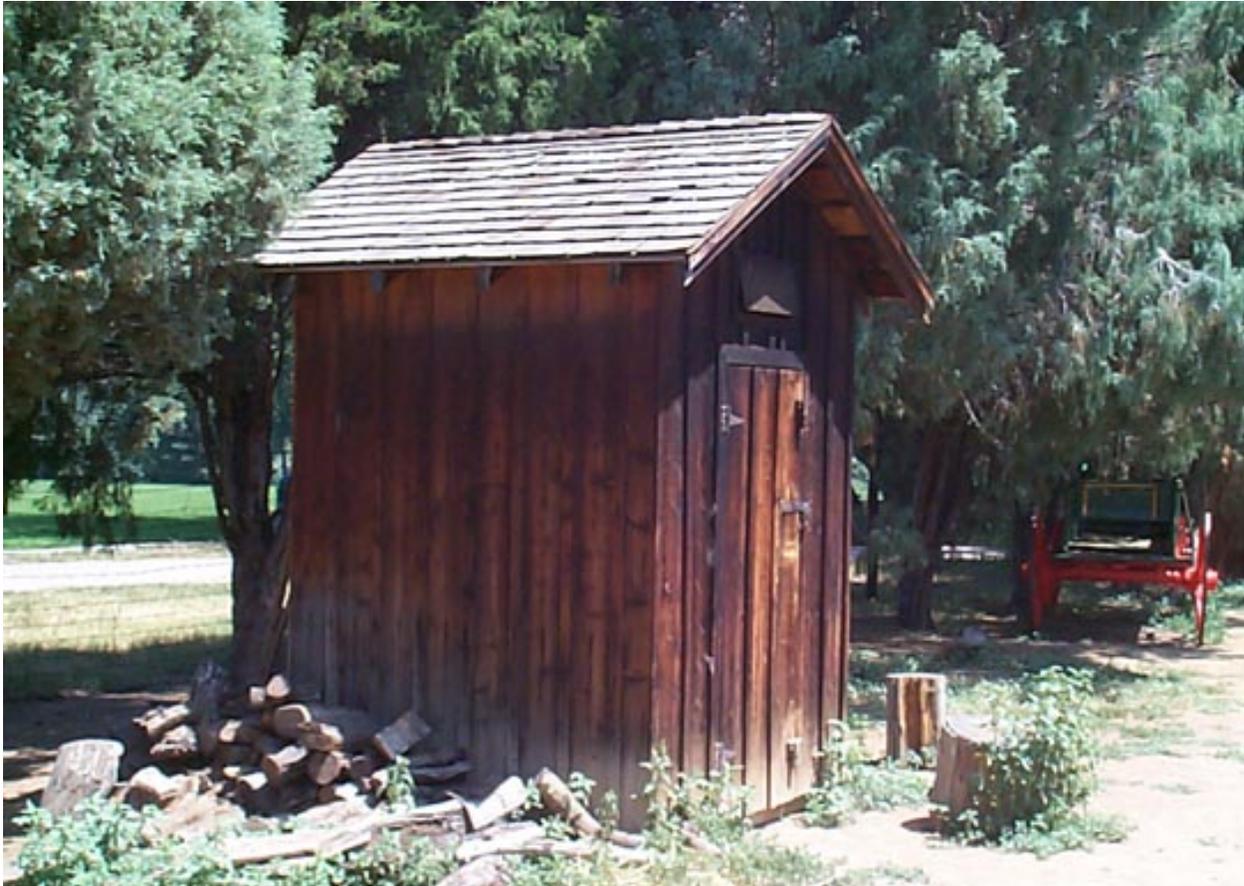
Smokehouse

The smokehouse is of frame construction and has a cobblestone floor. The interior walls are of lath and plaster. They are plastered over to retain heat inside. This insulation also prevents the building from catching fire. The meat is hung on overhead racks. The wood used to smoke the meat is always hardwood—apple, hickory, or oak. The preferred wood is either apple or hickory.

Smokehouses are used to flavor meat, but rarely to cook it. Even so, this smokehouse sometimes reach temperatures that will actually cook the meat. No soft wood like lodgepole or Ponderosa pine should ever be used in a smokehouse. Soft woods leave a residue on the wood inside. The residue will then taint the meat to be smoked. Even now, the smokehouse is used once or twice a week to prepare pork or poultry on the farm.

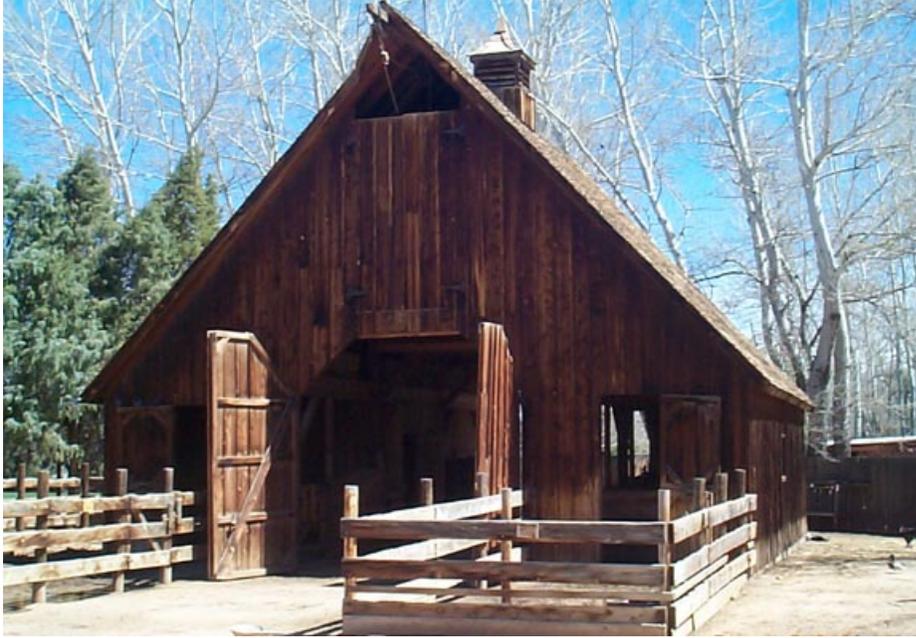
Barn

The barn has a central alleyway with stalls on either side. The horse stalls are on the side of the barn you see in the photo. A storage room is also on that side of the barn. This room is used to store tools and tack (e.g., harness). There are three different loft areas overhead. As you can see, the loft stores hay and alfalfa. It also stores straw. In addition, buggies and other wagons are often parked in the barn.

This barn is a reconstruction of barns that were common to the South Platte River Valley in the later 19th century. This post-and-beam barn was built at a community barn-raising. Post-and beam construction had long been a part of American building styles. Large timbers make up all the interior frame structure. The upright posts are held in place by braces. These, in turn, are held together by mortise and tenon joints. Wooden pins then hold these in place.

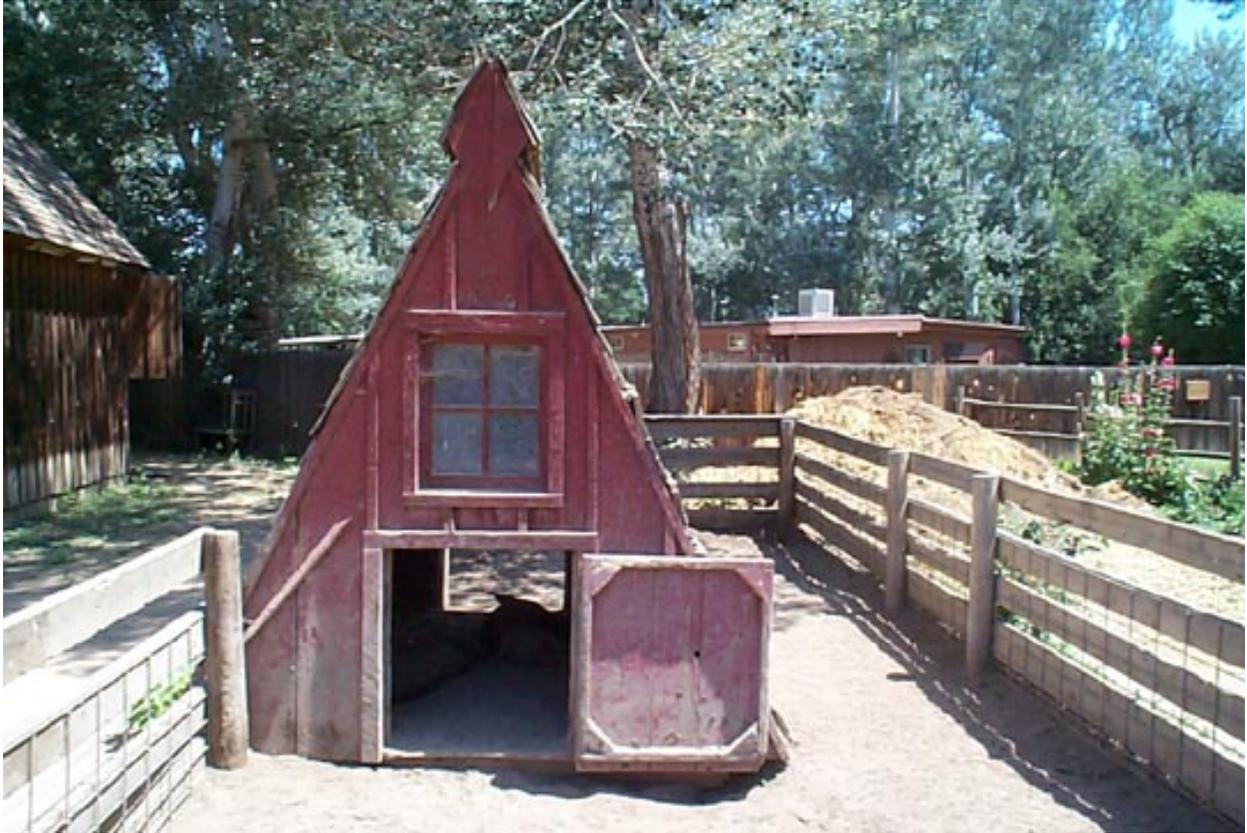
Hog house

The hog house was built as an A-frame. Questions often arise as to why farmers would have built some of their buildings in this fashion. In fact, U.S. Department of Agriculture publications in the later 19th century recommended the style. These publications included plans for the construction of A-frame hog buildings.

The triangle shape A-frame has several virtues for housing hogs. One is that it allows the sow (mother pig), when she is having offspring, to lie down without rolling on her newborn piglets. There is also an air vent system at the top of the A-frame. At the front of the A-frame is an area that is often wet and muddy. The pigs like to lay in the mud to stay cool.

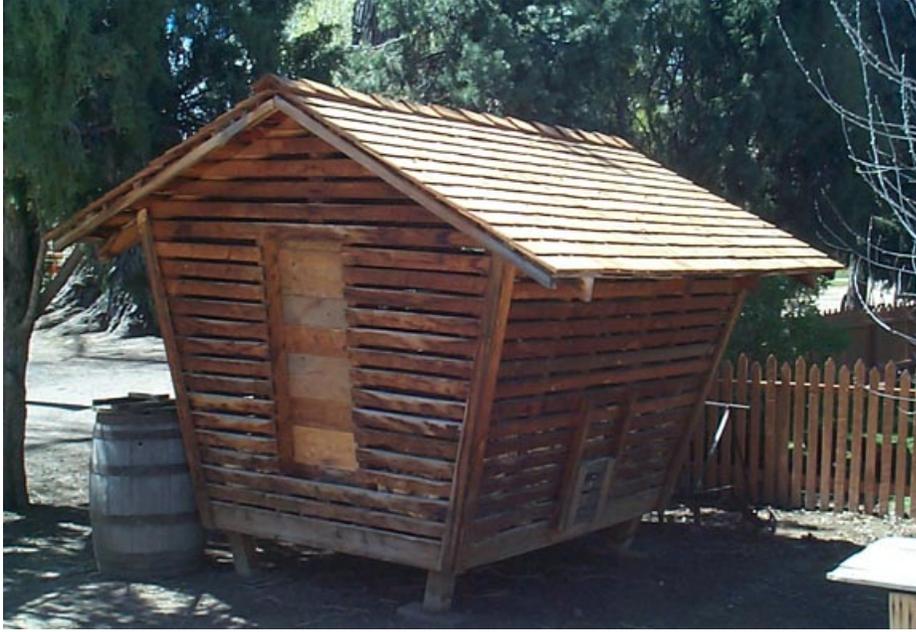
Corn crib

Behind the house and close to the pig sty is the corn crib. The crib was built up off the ground. One reason for that was to keep rats from getting into the corn. You can also see that there are spaces between the boards of the crib. These spaces allowed air to move through the crib and keep the corn dry. The corn crib was close to the pig sty and barn because most of the corn was used to feed the farm's animals.

The corn crib was probably a more important building on an 1890s Colorado farm than it had been on an 1860s farm. The reason for that is that farmers probably raised more corn in the 1890s. Partly this was one result of irrigating crops. Colorado's yearly rainfall is small, usually under 20 inches. That amount of rain is too little to raise most corn varieties. With irrigation, however, corn crops can get the needed water.

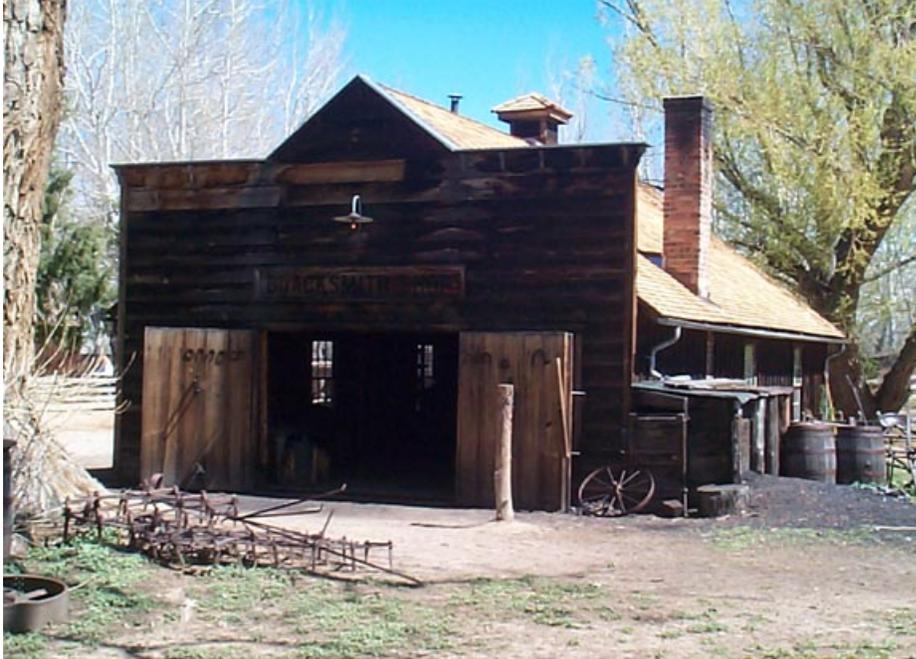
Blacksmith shop

To begin, a blacksmith shop like the one you will see in the photos here was not likely to have been on a farm. Still, many farmers had to be handy with tools. Anyway, the items in this blacksmith shop included anvils, bellows, forge, and hand tools of various kinds. This shop is set up to represent the work of a blacksmith, not that of a farrier (horseshoer).

The blacksmith shop is a reconstruction rather than an original building. It was set up to show the blacksmith trade in about 1903. Littleton got electricity after 1903. SO some of the tools in the shop ran on electricity. The building is of balloon frame construction. It has board and batten walls and a shingle roof. The shop has a wooden floor except around the forge. It has a dirt floor around the forge. That makes working with hot steel much safer.

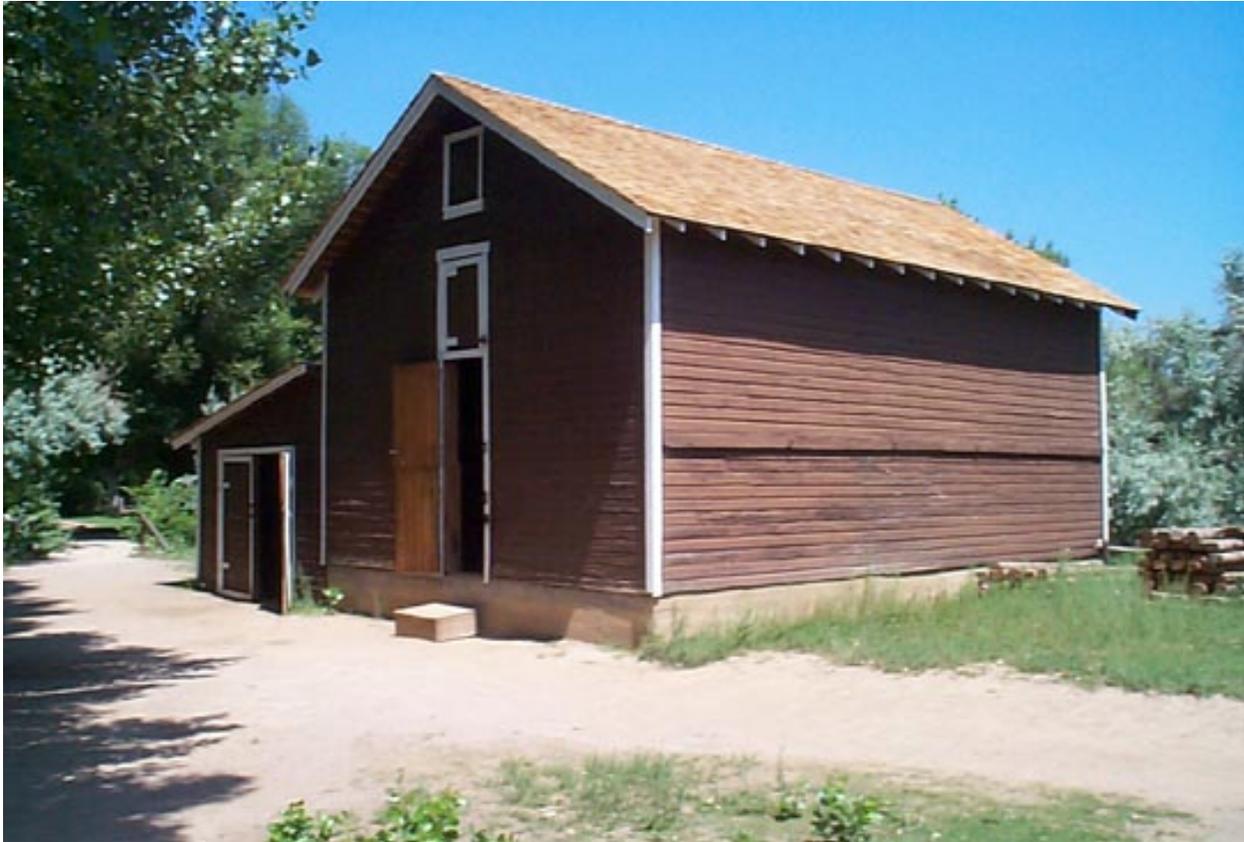
Icehouse

This building is an ice house. For us, ice houses are rather unusual buildings. The main part of the ice house is the original building acquired from the Beers Sisters' Dairy Farm. It was located west of Littleton near some large lakes. In the winter, ice was cut and pulled into the building. Blocks of ice were covered with sawdust and stored inside the building (in the area to the right). The ice was used in warmer months to cool the milk on the dairy farm. Before electric refrigeration, ice was also used to cool food in ice boxes. Ice cutting was a local industry of some importance to farmers.

The Littleton Historical Museum restored the Beers Sisters' ice house mostly by painting and cleaning it up. They also put it on a concrete foundation, as on its original site. A lean-to shed (in the photo to the right) was added to store the ice cutting tools and boat. Cutting ice in the Littleton region at that time depended on the weather. Ice needs to be at least 12 inches thick to cut into usable blocks. Sometimes the weather is cold enough along the Front Range, other times it is not.
