# VIRTUAL FRIELD TRIPS – DENVER’S LARIMER SQUARE

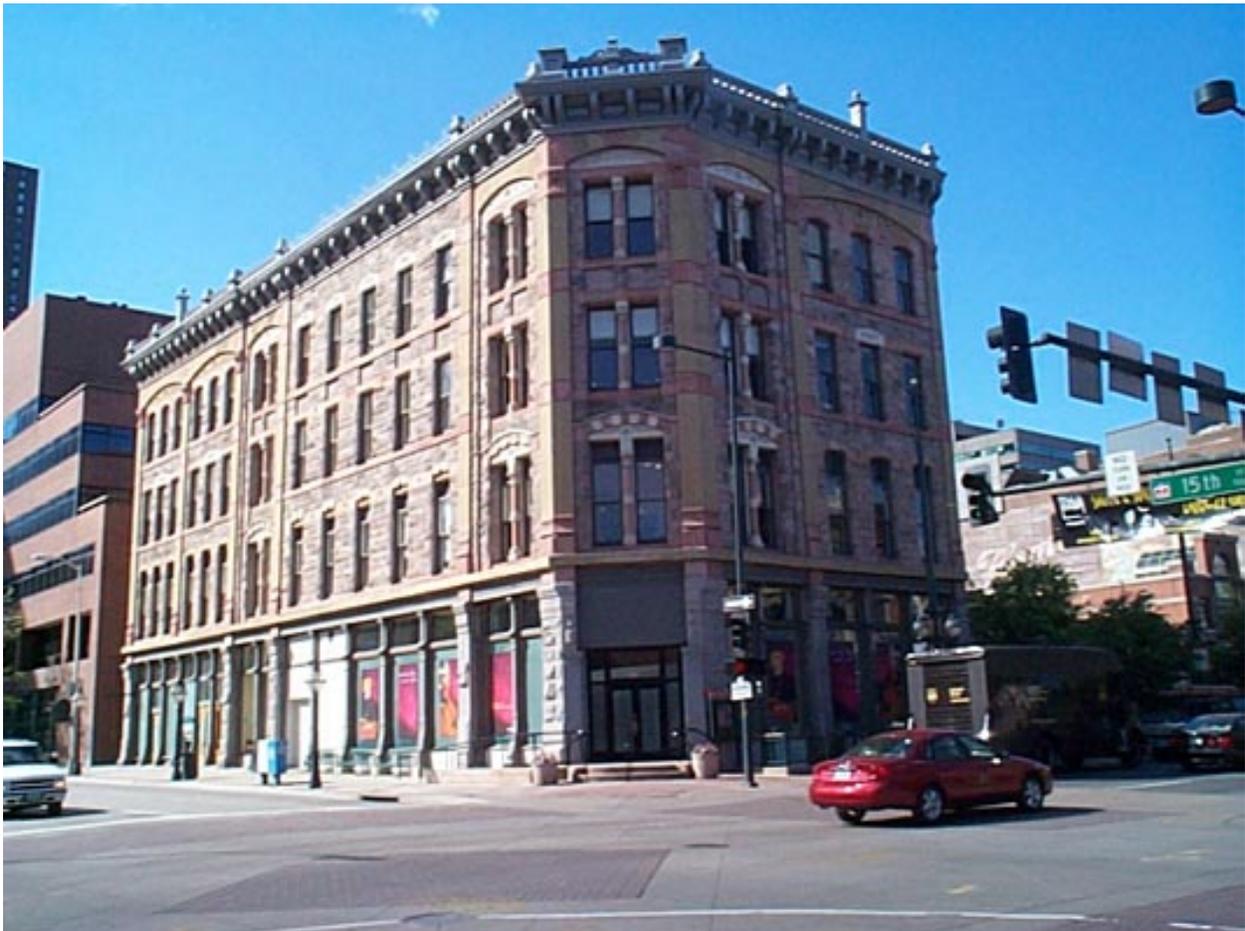
*The Clayton building*

During Larimer Square's restoration in the 1960s, the Granite/Clayton Building also experienced a renewal. There are several features that make this building unusual. First is its granite covering material. Second, the top edges of the building (known as a cornice) are unusual and interesting. Third, vertical

columns are made of cast iron, which are decorative when not covered by the granite. Fourth, the building has a number of stained glass windows. Finally, the front corner of the building, which has recessed bay doors and windows on the second through third floors, is also unusual.

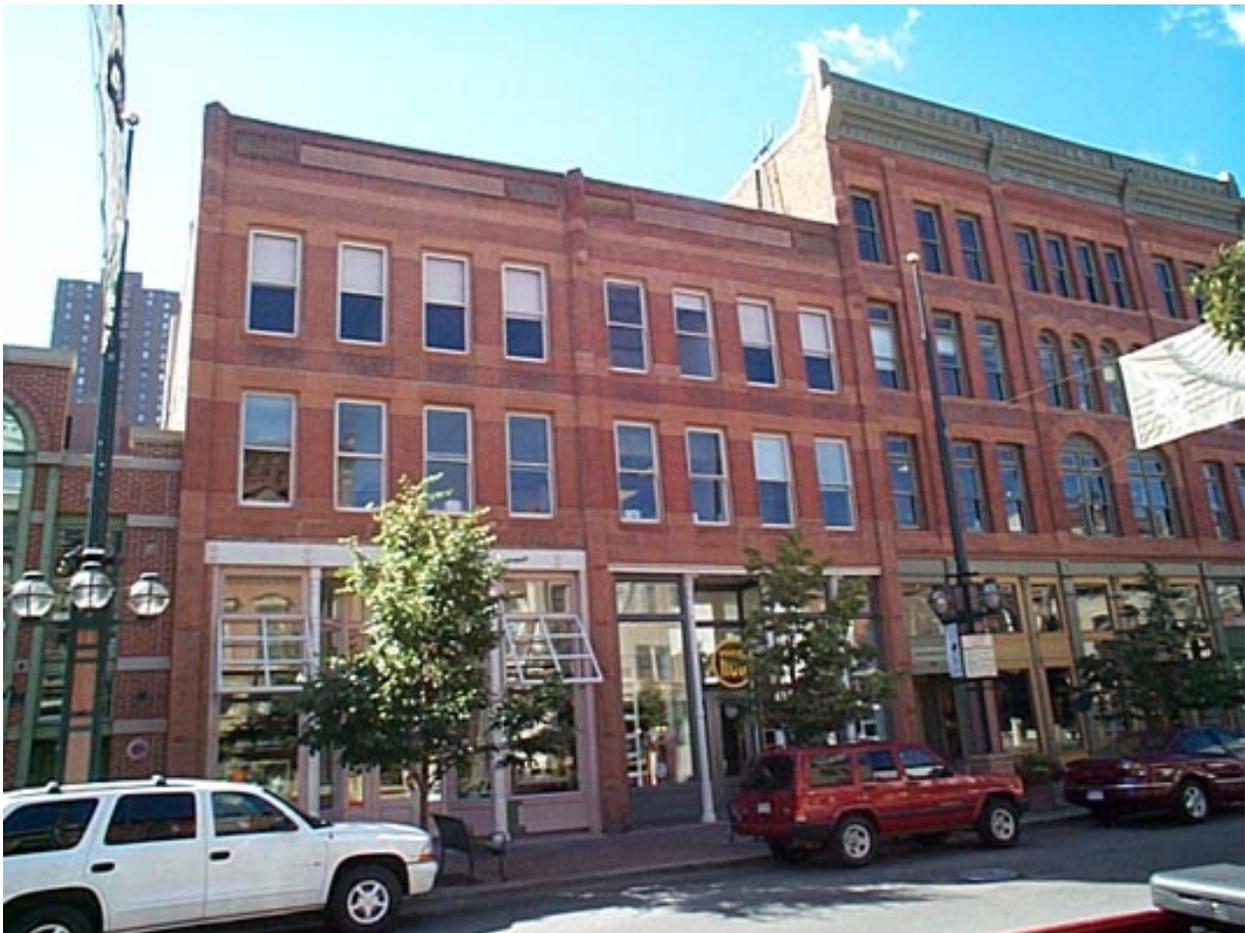
*The Buerger block*

The first half (to the left in the photo) of the building was built in 1890. The second half was built in 1908. You can see that the second part of the building was decorated to conform to the look of the first

half. The horizontal lines of the roof line and upper story windows are quite similar. So, too, is the brick used in construction. The doorways were quite different in design and look.

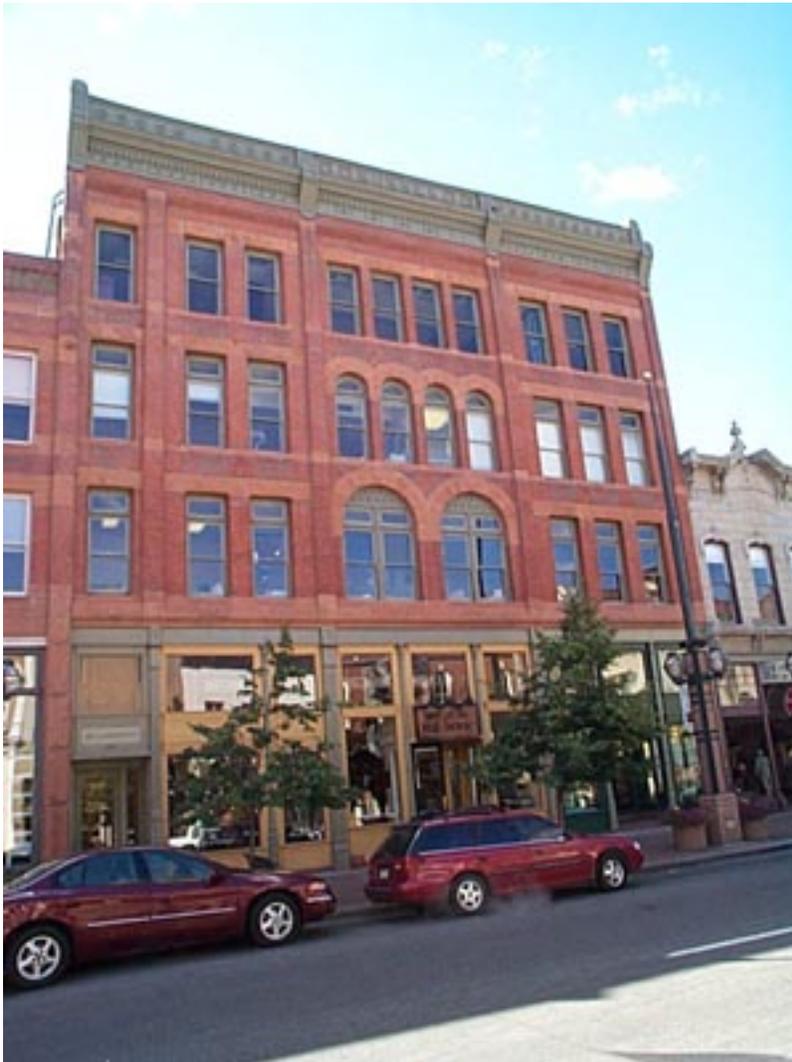
*The Sussex block*

The Sussex Building is made of red brick. The brick work around the windows and composing the vertical columns is decorative. It also lends a solid, massive feel to the building. The round arches of the second- and third-story windows illustrates a Romanesque architectural style.

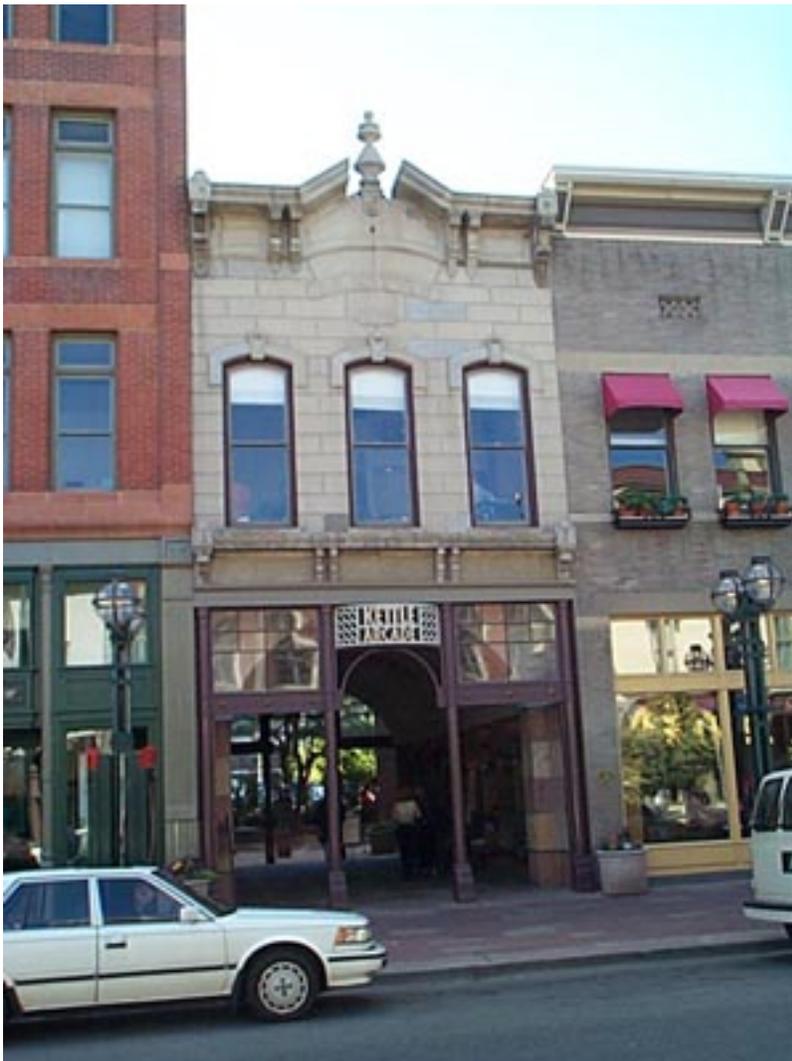
*The Kettle building*

In mid-1859, Count Henri Murat opened a barbershop on this site. George Kettle, a butcher, built the building named after him on this location in 1873. He wedged his building in between two other buildings that had already been built. One interesting thing about this building is that it had no side walls of its own. Rather, it used the side walls of the buildings that were already there.

Not long after it was built, Mr. Kettle left his building. Kettle himself went into the real estate business. After Kettle left it, the building housed many different businesses. At various times it served as the home for an employment agency, a knick-knack store, a newspaper office, and a steam dye works. In terms of design, the building is most notable for its simulated stone facing and the decorative top (cornice) of the building.

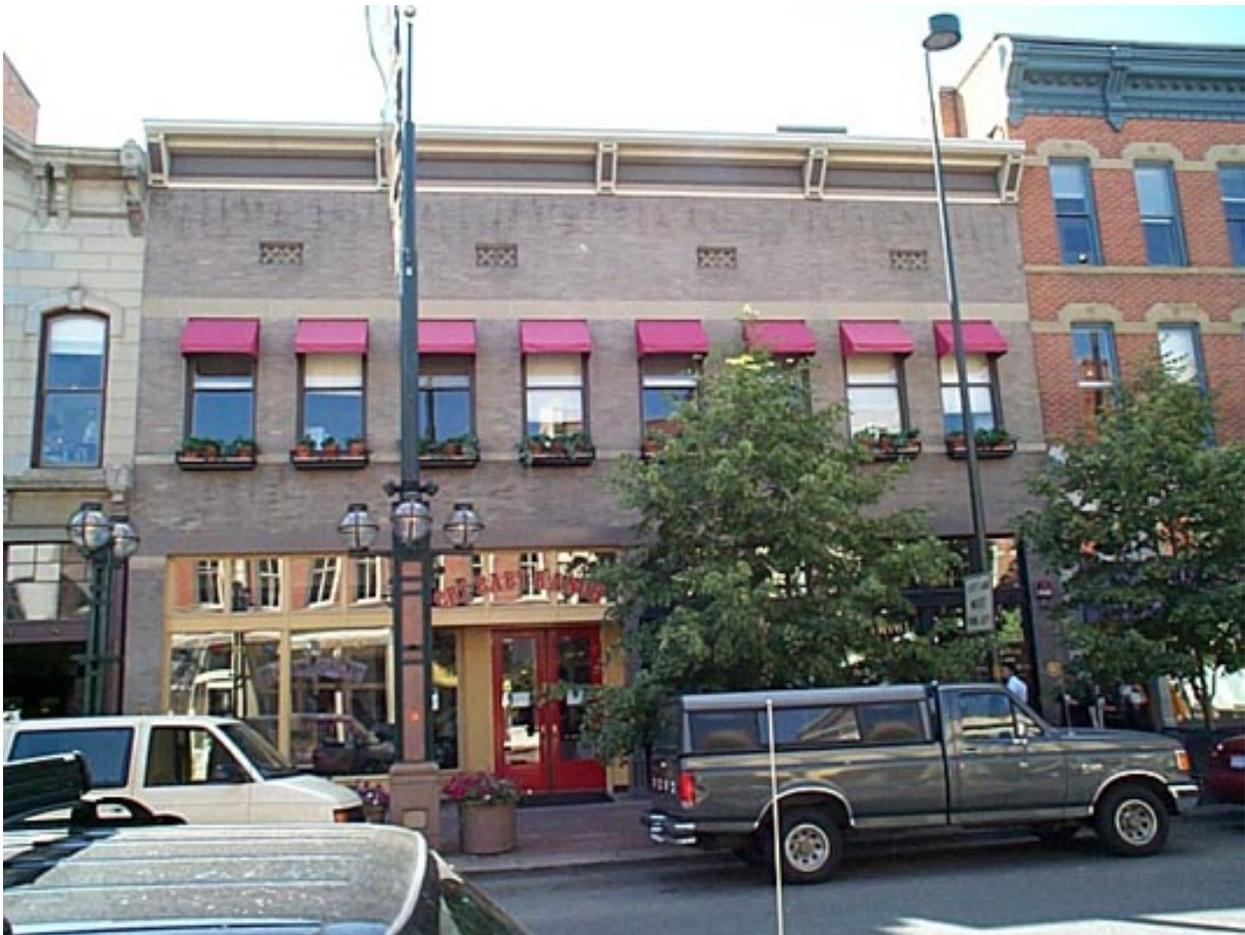
*The Wooten building*

The current occupants of the Wooten building are similar in scale and type to the buildings that originally occupied this location. The gray brick face of the building was added in the early 1900s. This facing supplies a design unity to the various shops that occupy the building.

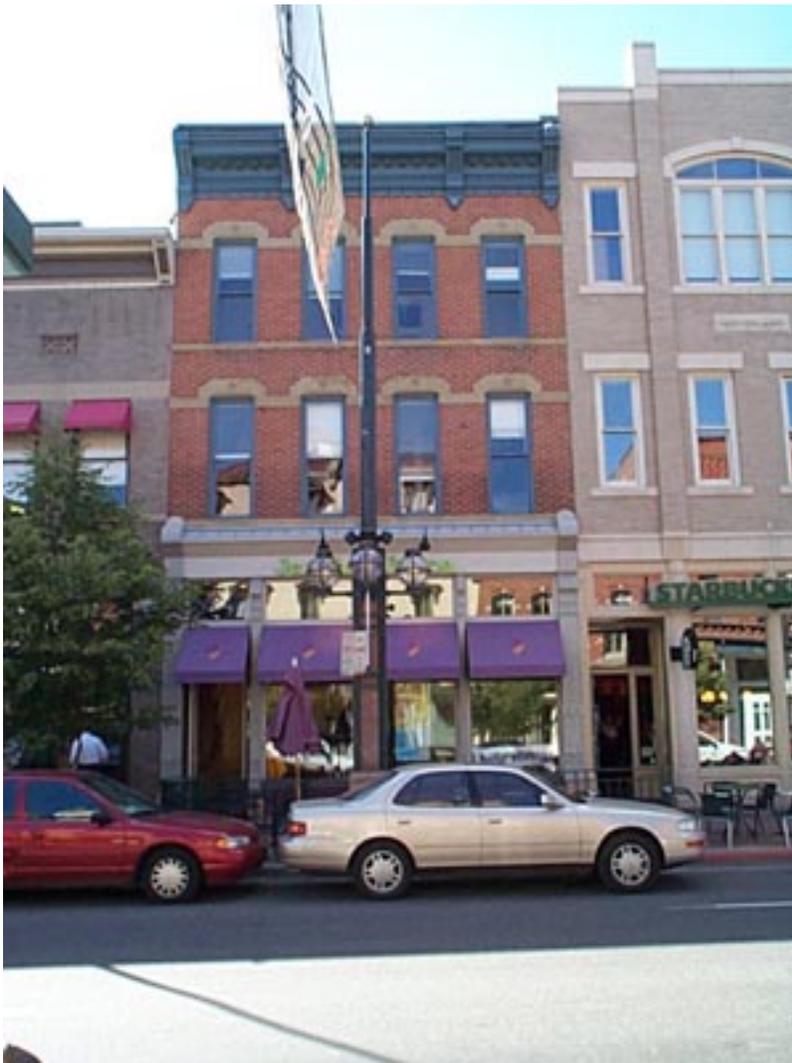
*The Barnum building*

The Barnum building was built in the 1880s. It is a red brick, three-story building. Its fine appearance is partly the result of fancy stone trim around and above the building's windows.

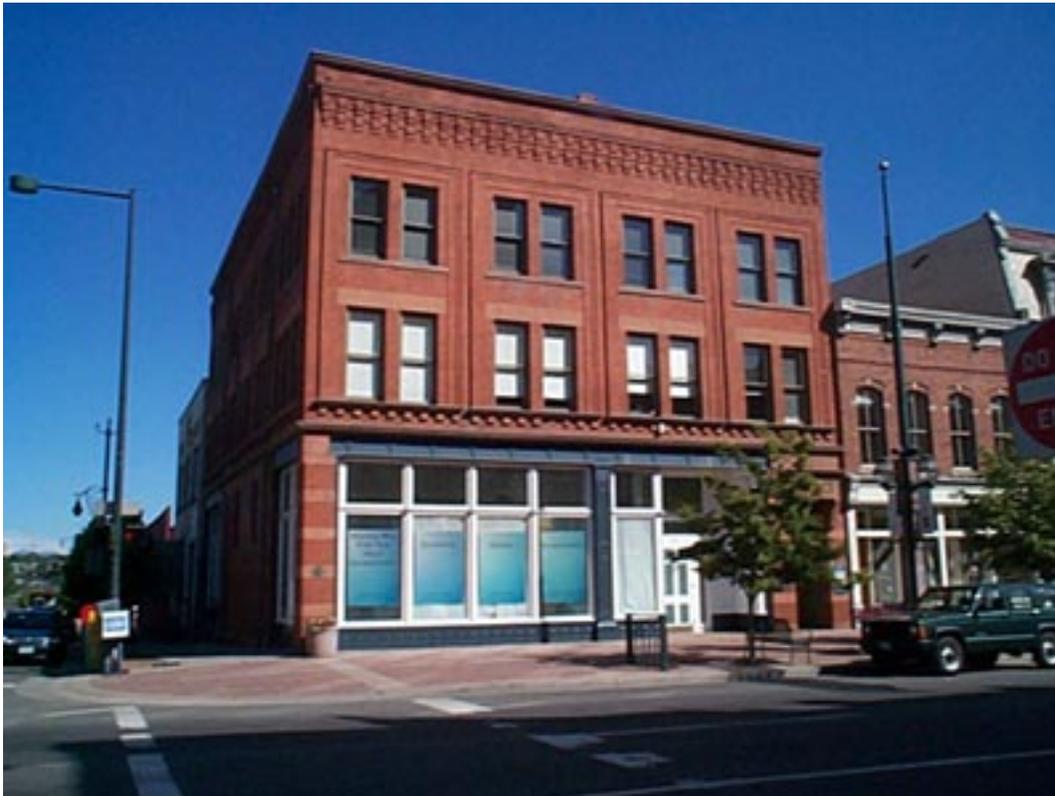
*The Miller block*

The Miller block you see in the photo was built around 1890. It is a sturdy red brick three-story building. It is decorated in a number of ways. These include the brick work along the top of the building and the contrasting colored masonry above the windows and on the corners. The building is cubic in design and shows no projections or recessions on any wall. The first floor has a cast iron frame to display goods in the front windows.

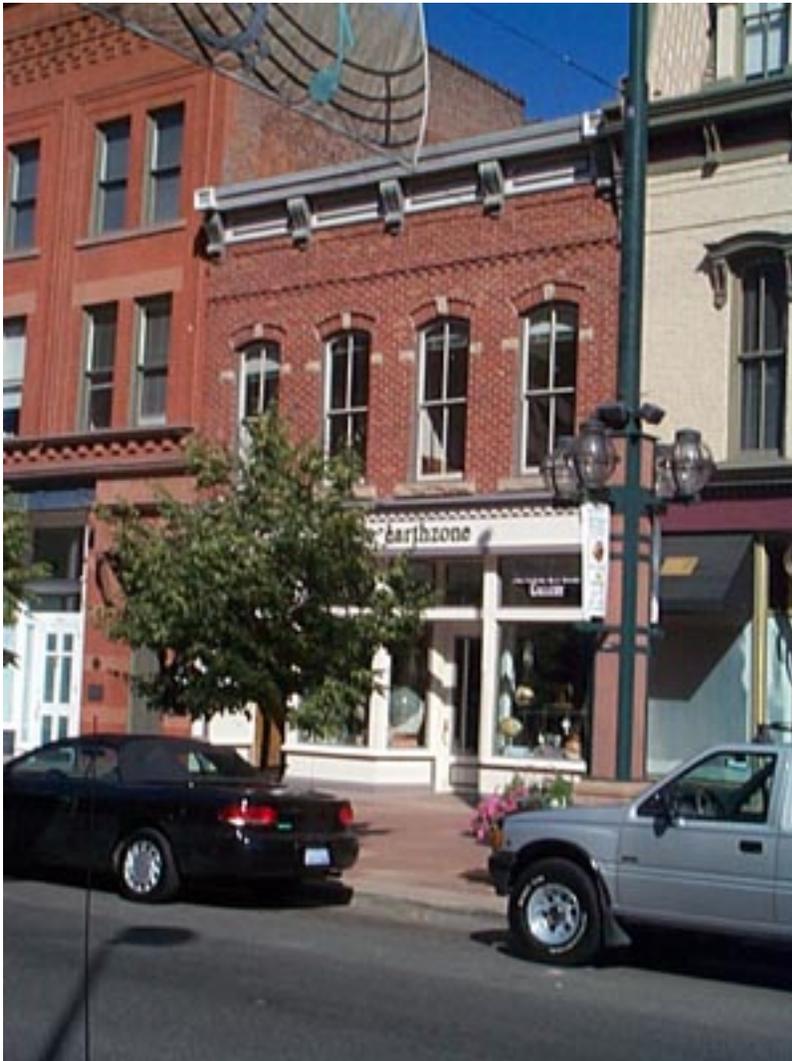
*The McKibben building*

The original brick two-story building has experienced many changes to its face during its lifetime. The brick work is very decorative, especially around the windows. The top of the building has a bracketed cornice (the gray material at the top of the building). The entry way is recessed from the sidewalk in the front.

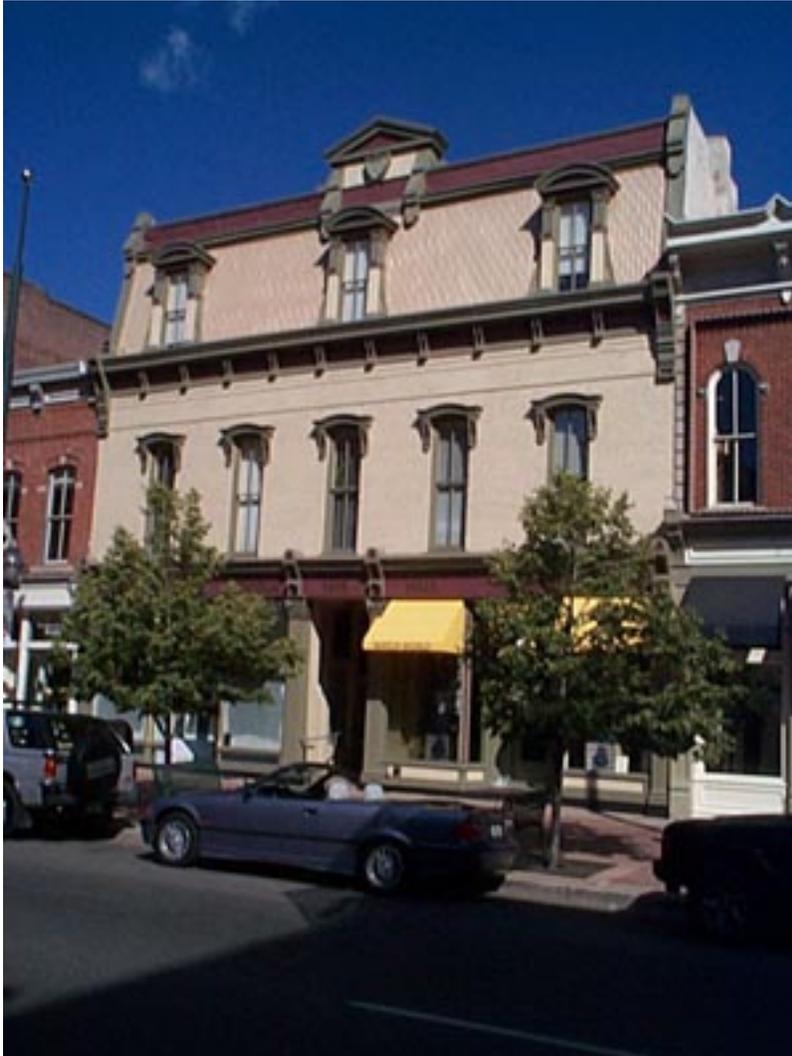
*Lincoln Hall*

Lincoln Hall is a good example of the Second Empire style of architecture. The building has the only mansard roof in the Larimer Square Historic District. The building is also interesting because of the three third-story rectangular dormer windows and a cupola (on the top, middle of the roof line). The first floor is framed with cast iron. The iron columns have Greek-style decorations.

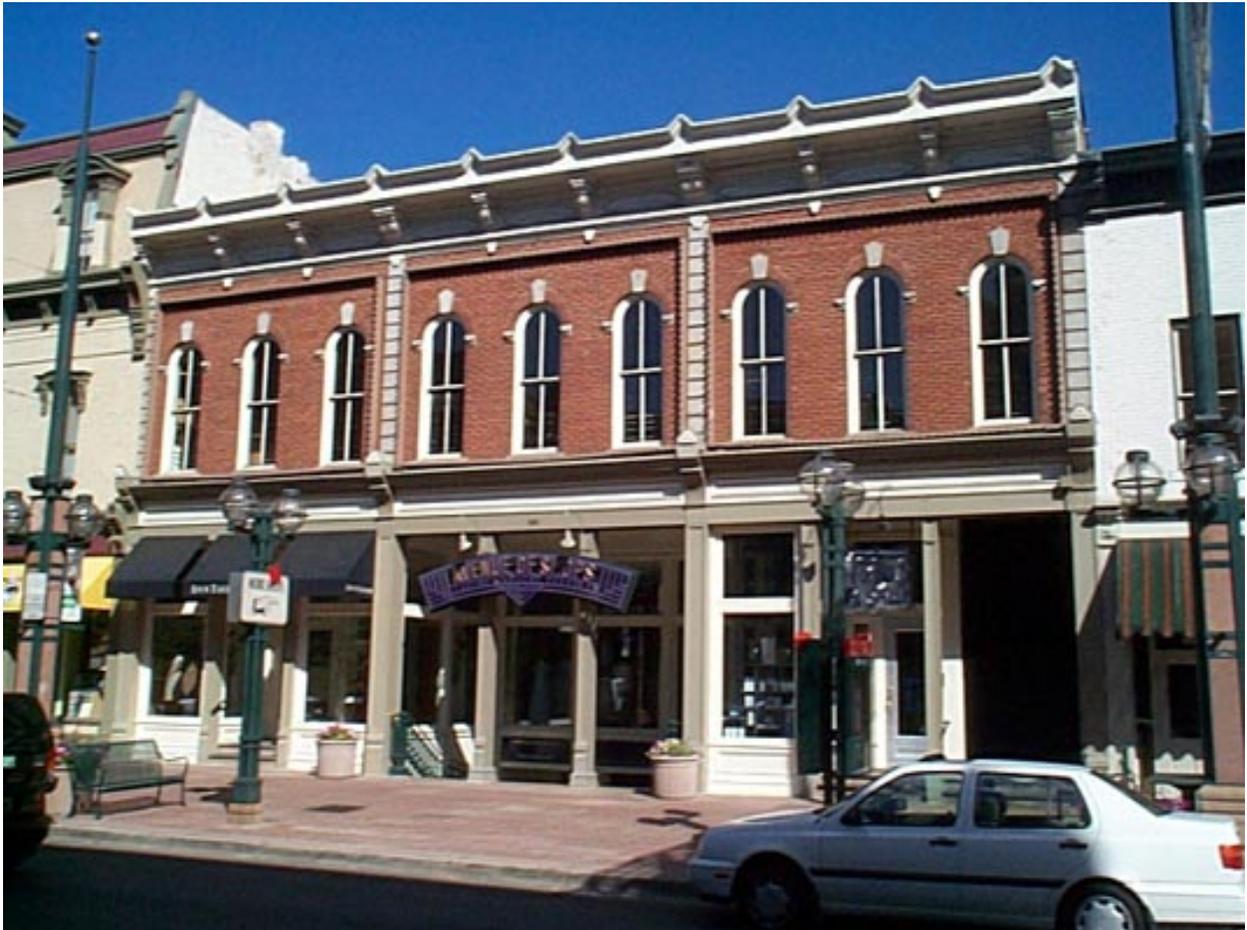
*The Congdon building*

The Congdon building was completed in 1870. It is a long, red brick building that actually looks like three buildings in one. The second-story windows are rounded. You can also see a keystone in the arches above each of these windows. At the top of the building is an over-hanging cornice (the gray material running along the roof line). You can also see the fancy brackets folding up the cornice.

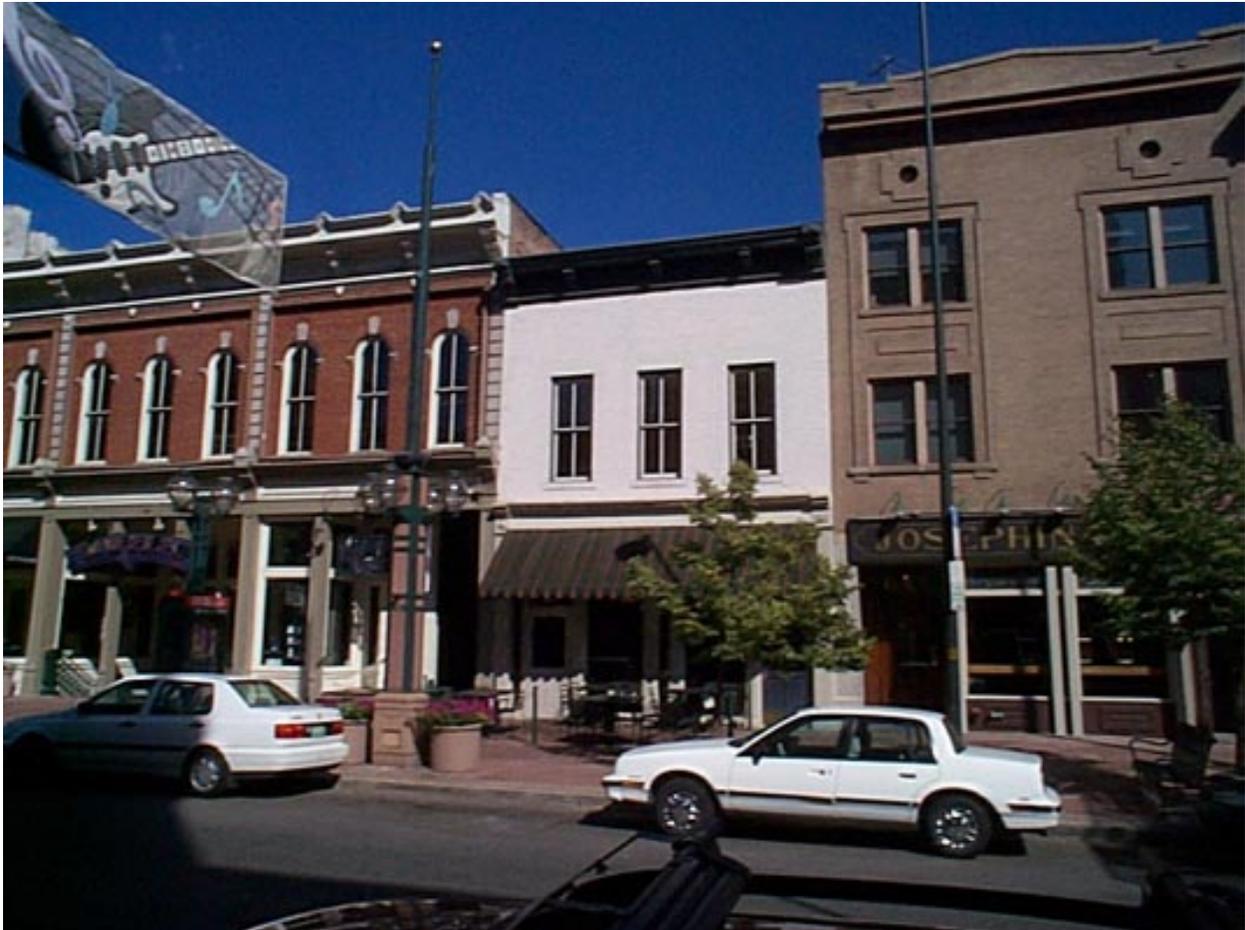
*The Looms building*

For twenty years, this site was the location of a wooden cabin and then a small brick building. In the 1880s, the Looms building was built on this site. It was a plain brick and wooden structure that survives to this day. The building has three rectangular windows on the second story. Decoration to the building is supplied by a fancy cornice (along the roof line) and the bracketed eaves holding the cornice.

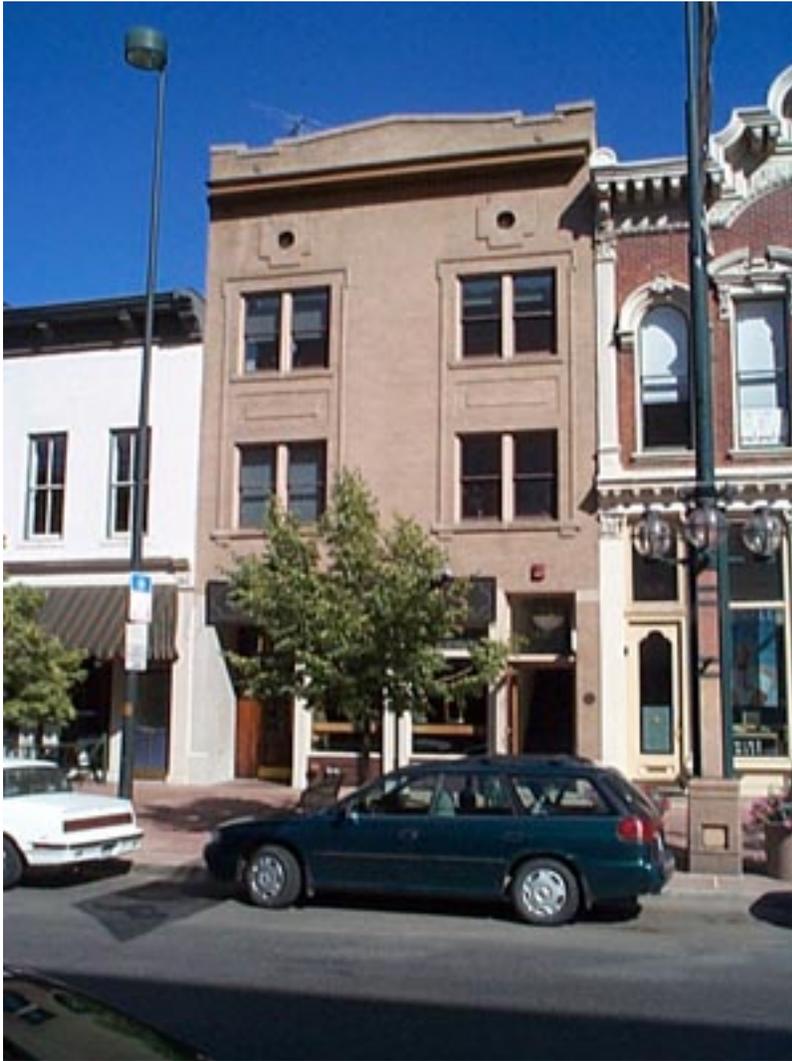
*The Frontenac building*

The completion date of the Frontenac building is not certain. This narrow three-story building has a decorative masonry front. You can also see round (port hole) windows in the attic. The build is topped with a jagged, decorative, roof line and a false cornice just below that.

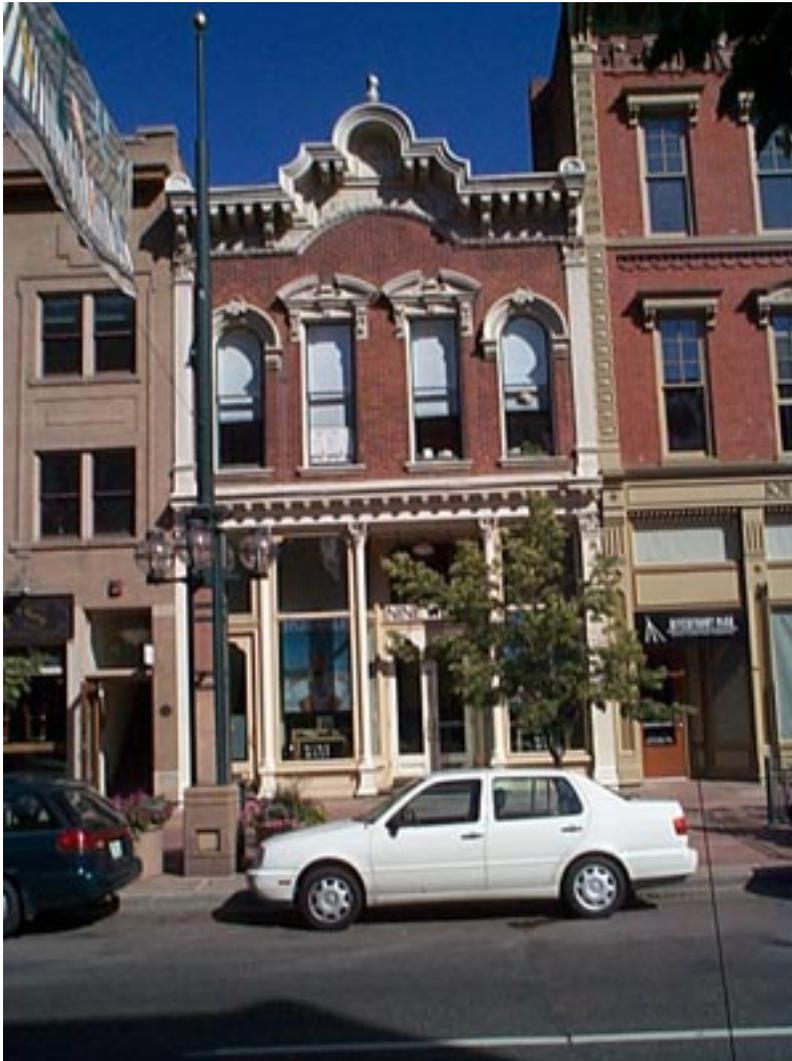
*The Crawford building*

The Crawford building is a good example of the Second Empire architectural design. This design has very fancy ornamentation at the top (cornice), around the windows, and on the first floor. The building was renamed in honor of Dana Crawford. She spearheaded the rehabilitation of the Larimer Square Historic District. According to historian Tom Noel, Crawford said "I used to go antiquing in the old pawnshops down on Larimer. Then one day I noticed that these buildings themselves were fabulous antiques."

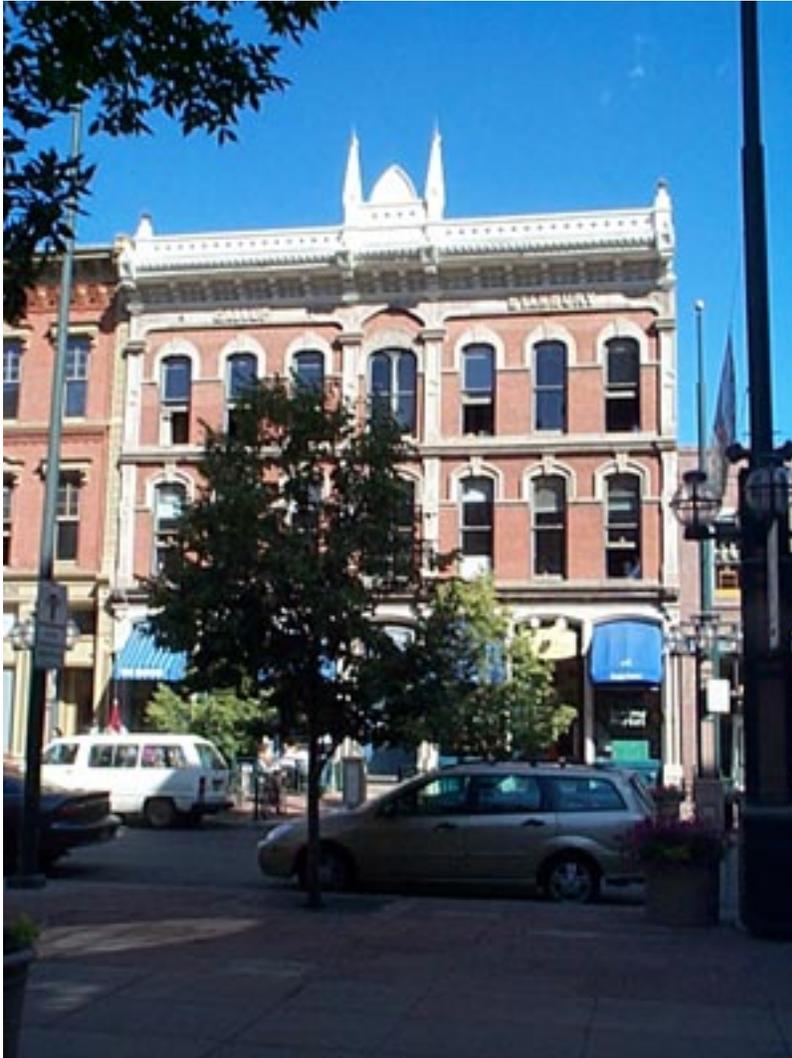
*The Gallup-Stanbury building*

This 1873 building is basically Italianate in design. It is made of brick with decorative stone work. This stone work includes arches over all the second-and-third-story windows as well as in the columnar effect on the sides and in the middle of the building. Stone also provides lintels (arch effects) for the windows on the first floor. You can also see the fancy cornice (along the roof line) with a spired parapet at the very top of the building. You should also be able to see the name of the building (just under the cornice).

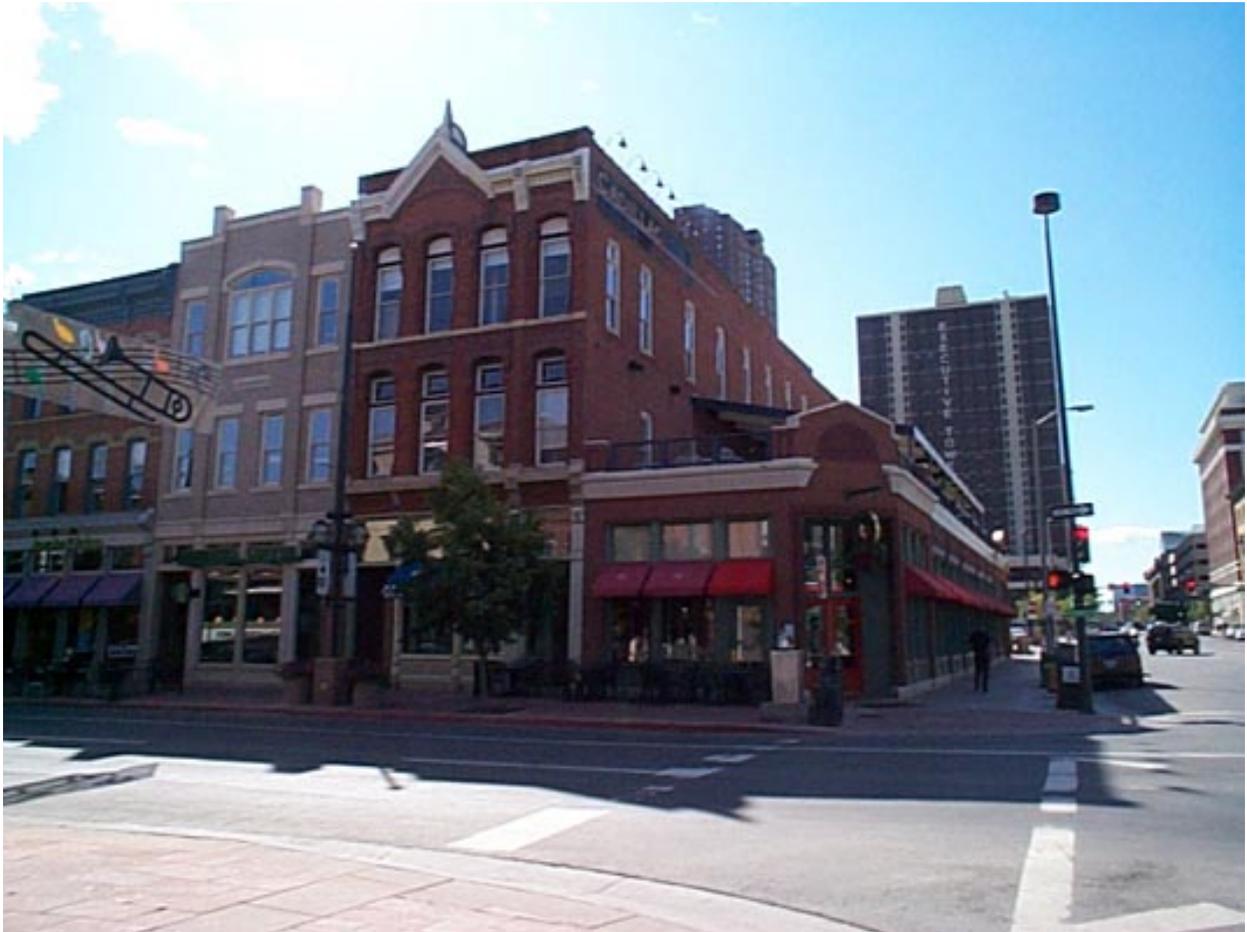
*The Hope Hotel*

One of the distinctive features of the Hope Hotel building is the metal strip (called a frieze) near the top of the building. Also of interest is the off-center pediment (that is part of the frieze). In 1993, a one-story addition was added and the whole building was redecorated in red brick and red stone. This masonry work matches nicely that of the rest of Larimer Square. If you compare this building with others in this block, you can see many of these similarities.
